28 Anne Dr  
Freehold, NJ 07728

**Inspection reference: 060918JM1**

**Confidential Inspection Report**  
**28 Anne Dr**  
**Freehold NJ 07728**

**June 9, 2018**

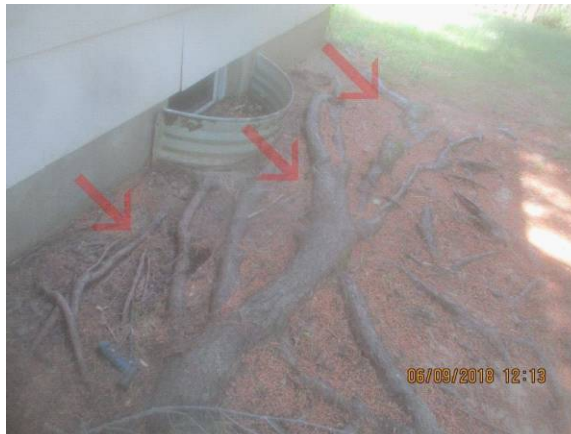
**Tree roots along rear foundation wall.**

POOR. Recommend adjusting the grade around the foundation to direct water away from the house. This will require removal of the tree roots that run along the rear and right side foundation walls. This may help to reduce moisture within the structure. Be sure to maintain an approximate six inch gap between the siding and the soil level to help reduce the potential for wood destroying insect activity.

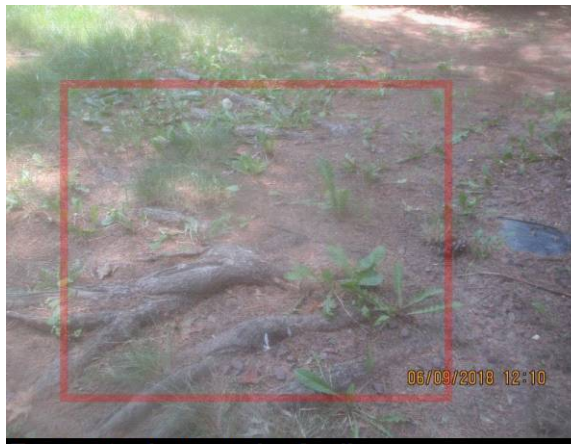
**Tree roots above grade of soil.**

potential for further structural damage. There is an extensive number of large roots that protrude above the grade of the soil. These roots present a trip hazard. Have a qualified tree contractor remove the roots - where possible to improve safety. Branches, of other trees near the house, should be trimmed back away from the house. Shrubs should be cut back from the house to help reduce the potential for insect activity and moisture accumulation. Keep trees and shrubs trimmed away from the house. Monitor condition of trees and prune as needed.

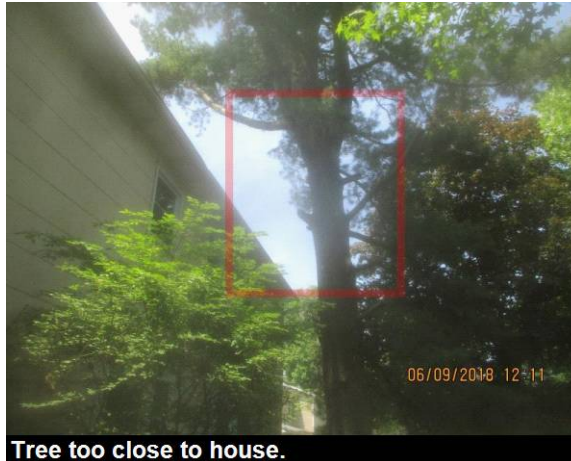
Tree too close to house.

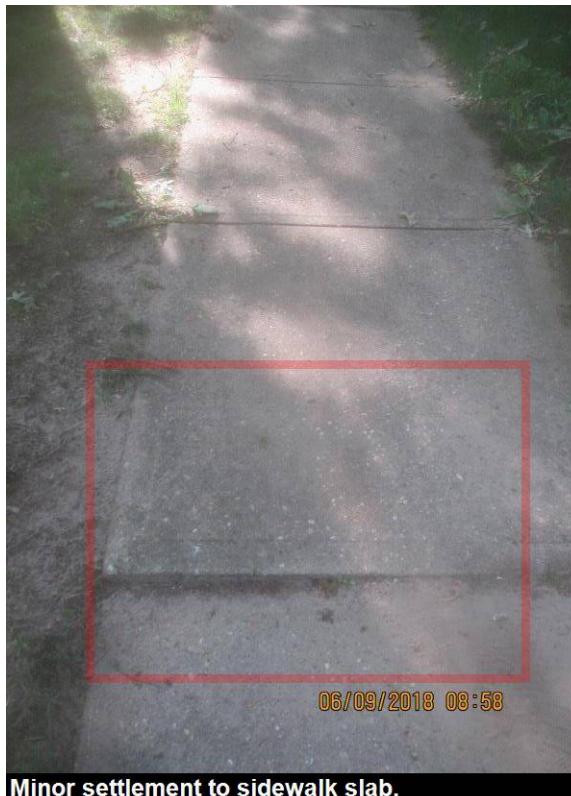
Minor settlement to sidewalk slab.

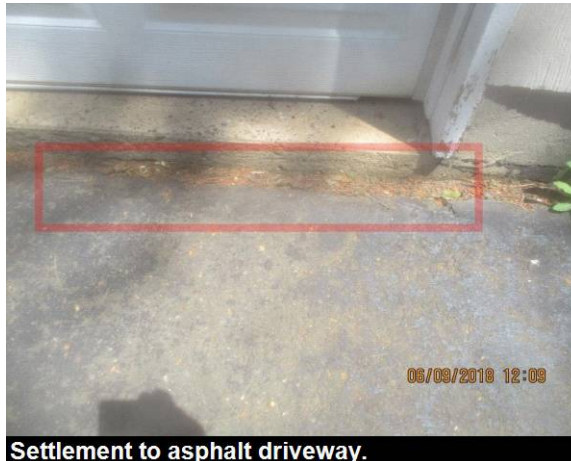
**Settlement to asphalt driveway.**

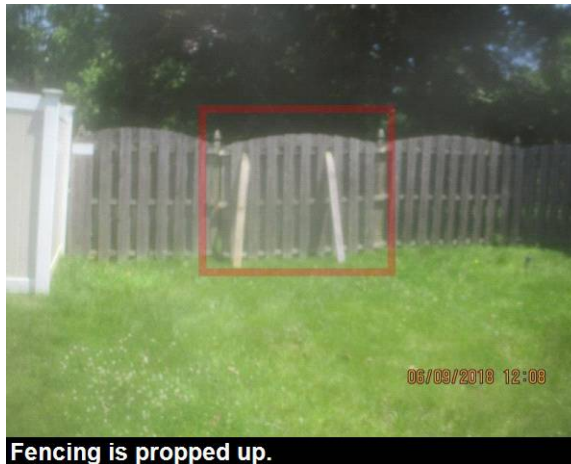
POOR. Rot and deterioration noted to the old wood fencing in various areas around the perimeter of the lot. The gate is also loose and damaged. Have a qualified fencing contractor replace the damaged sections of fencing as well as the gate.

**Fencing is propped up.**

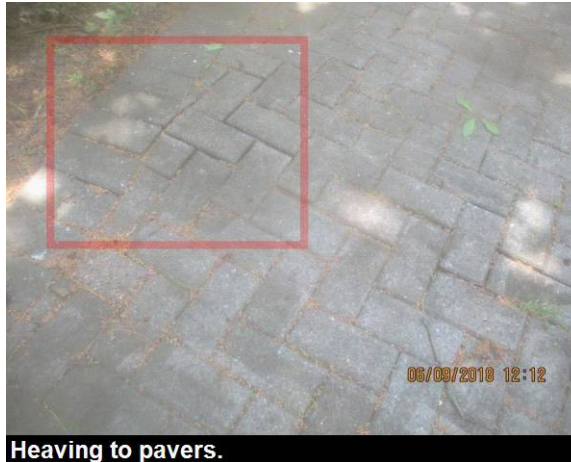
**Heaving to pavers.**

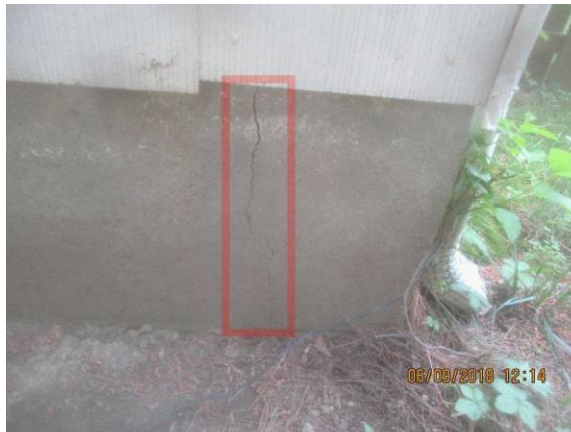
Condition: (As noted from the exterior) FAIR. Multiple cracks are visible in the rear foundation wall. See the Basement/Structure section of the report for additional information.

**Vertical crack in rear foundation wall.**

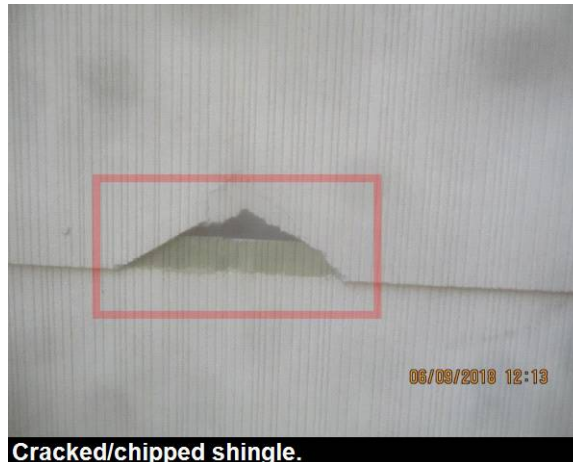
**Cracked/chipped shingle.**

POOR. This home contains the original fiber cement shingles. These shingles likely contain asbestos - due to the age of the home. Chipped and cracked shingles noted in various areas around the perimeter of the home. These shingles should be very carefully replaced (care should be taken not to further crack or damage the shingles) during removal due to the strong potential for them to contain asbestos. The damaged shingles should be replaced by a qualified siding contractor. The loose shingles, at the top of the left side gable and under the window in the rear wall, should be secured by a qualified siding contractor. The inspector does NOT perform asbestos testing. Consult a qualified environmental contractor for further evaluation, as desired, PRIOR to closing.

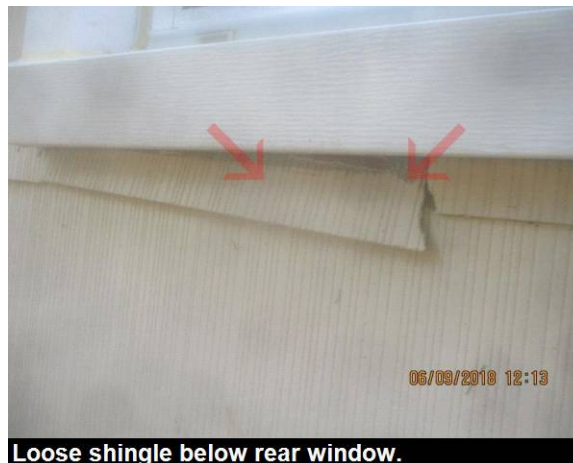
**Loose shingle below rear window.**

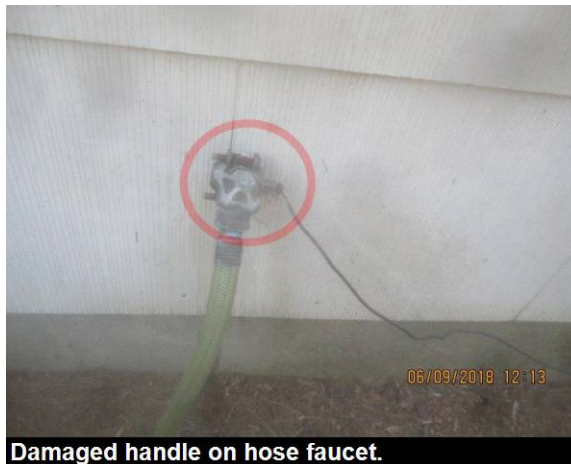
Condition: FAIR. The handle, on the faucet located on the rear wall of the home, is damage. Have a licensed plumber replace the handle to improve safety. The installation of frost-proof faucets is advised. It is advised to turn faucets off, inside, during the winter season to help reduce the potential for freezing and damage to the faucets and piping. Recommend installing an anti-siphon device prior to each hose connection if not presently installed to help reduce the potential for potable water contamination. (Inexpensive)

Damaged handle on hose faucet.

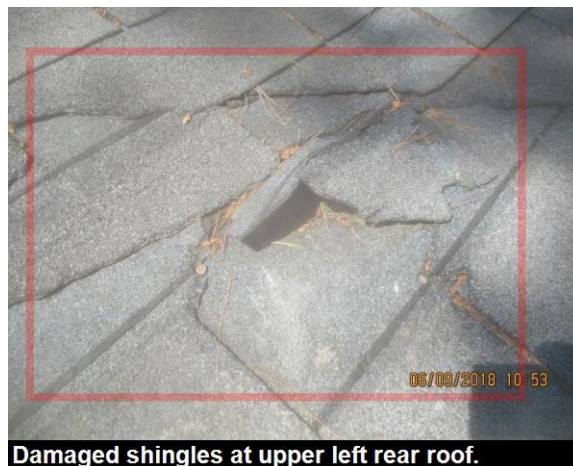
**Damaged shingles at upper left rear roof.**

**POOR.** Several damaged shingles noted at the left area of the upper rear roof deck. Extensive asphalt granule loss noted to the shingles (especially in the left area of the front upper roof deck). The top layer of shingles is likely 20+ years old and **BEYOND THEIR USEFUL LIFE**. The roofing requires replacement at this time. Have a qualified roofing contractor replace the roofing. Obtain estimates, from qualified roofing contractors, for replacement PRIOR to closing. As two layers of shingles are present, **BOTH LAYERS WILL REQUIRE REMOVAL BEFORE NEW ROOFING CAN BE INSTALLED.**

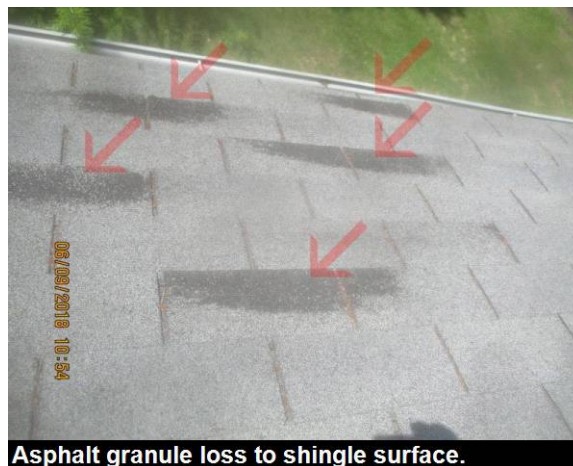
**Asphalt granule loss to shingle surface.**

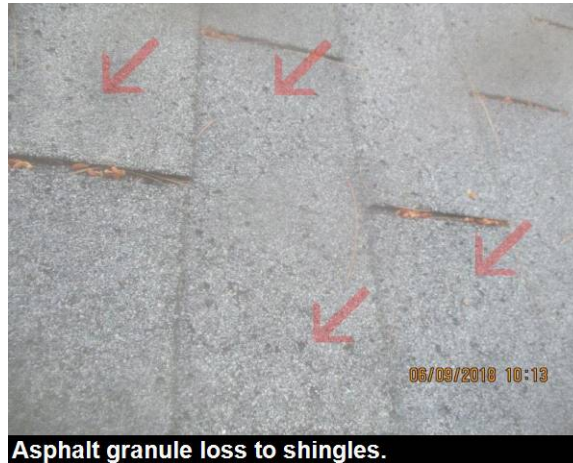
**Asphalt granule loss to shingles.**

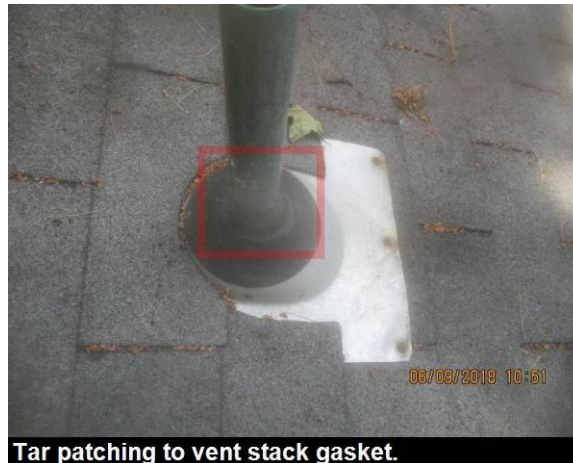
**Tar patching to vent stack gasket.**

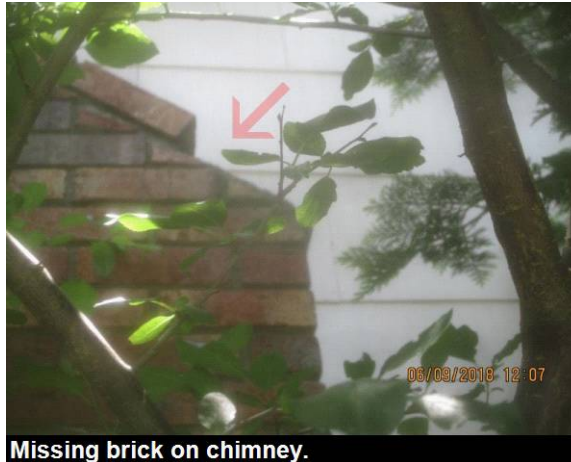
**Missing brick on chimney.**

POOR. A brick has fallen off the front left corner of the lower diagonal section of the chimney. The brick is laying on the ground near the chimney. Thin cracks noted in the concrete crown at the top of the chimney. Have a qualified chimney contractor make all necessary repairs to reduce the potential for deterioration to the masonry. Water accumulation noted inside the bottom of the chimney (visible through the cleanout in the basement portion of the chimney). Recommend that a proper rain cap be installed on each of the two flues to prevent moisture, animals, limbs or leaves from entering the chimney area. Interior of the chimney not inspected. See the Fireplace and Heating section of the report for further information.

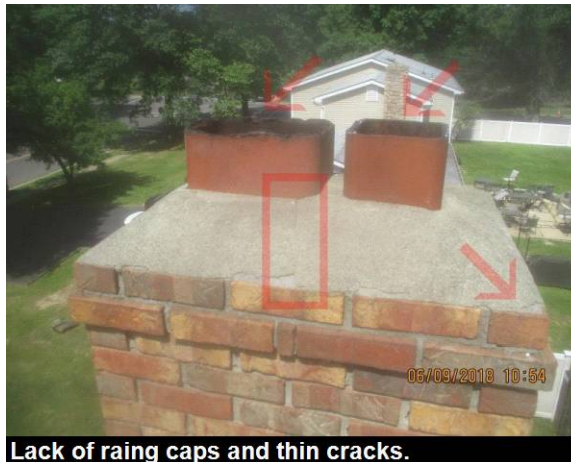
**Lack of raing caps and thin cracks.**

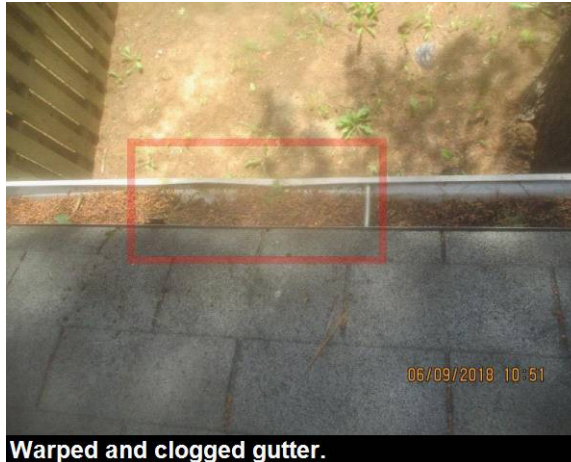
**Warped and clogged gutter.**

POOR. The gutters are warped, dented and loose in multiple locations around the perimeter of the home. The gutters should be replaced to allow roof surface runoff to drain into the gutters. Redirection of downspout outlets away from the house is advised to direct roof runoff away from the foundation. Keep gutters clean and keep water leading away from the foundation. Gutters require periodic renailling.

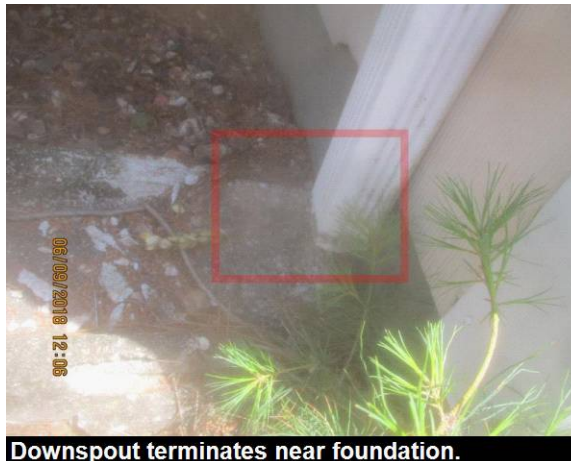
**Downspout terminates near foundation.**

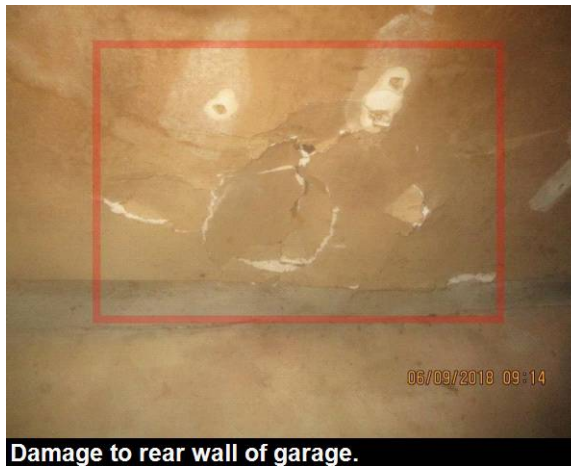
**Damage to rear wall of garage.**

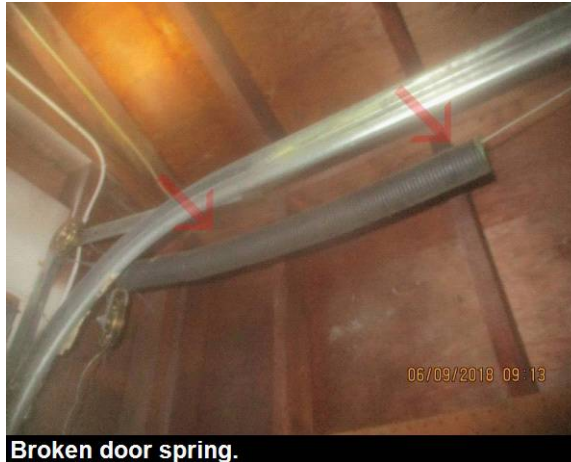
**Broken door spring.**

POOR. A damaged spring was noted on the left side door. Operation of this old door opener could NOT be tested. However, the door opener lacks a safety stop as well as infrared reversing beam sensors. The door will NOT reverse travel if an obstacle is encountered on the way down. The door opener should be replaced with a modern unit that contains infrared reversing beam sensors. The infrared reversing beam sensors are mounted too high above the base of the right door. The reversing beam sensors should be lowered to within six inches of the floor for safe operation of the reversing safety mechanism. Both doors do NOT seal well to the floor (there is a gap between the base of the doors and the concrete slab). New weather-stripping should be installed to reduce the potential for moisture, insect and rodent entry.

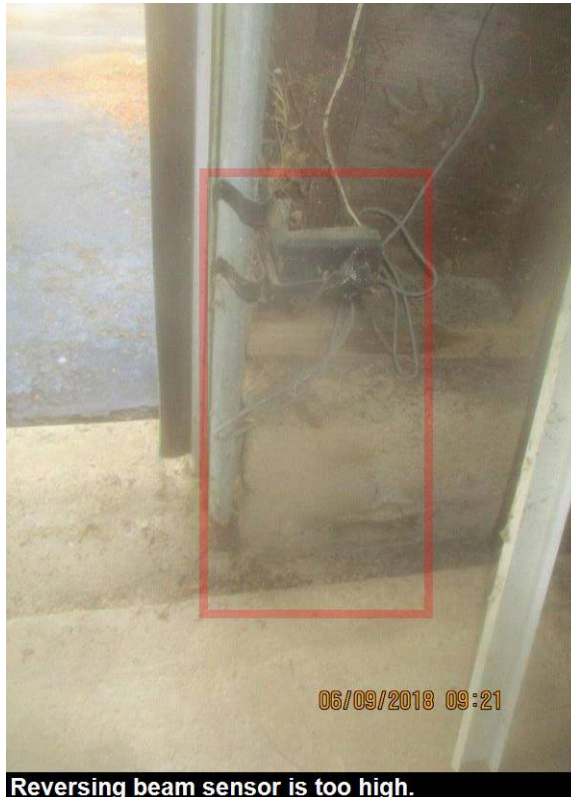
**Reversing beam sensor is too high.**

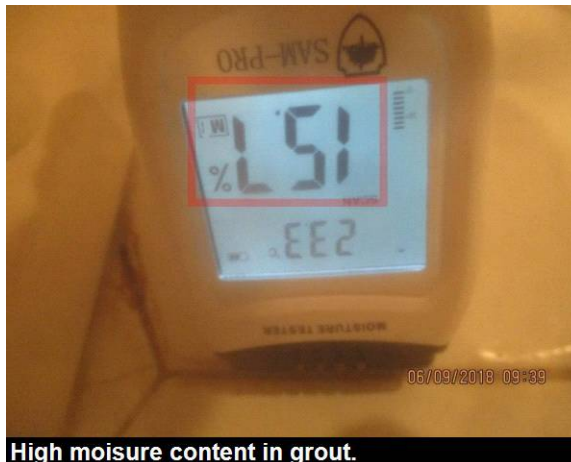
**High moisture content in grout.**

Condition: Fixtures & Surround: POOR. The stained grout between the ceramic floor tile (around the base of the toilet) tested damp with a moisture meter. There is likely a leak at the wax seal under the toilet. Have further evaluated by a licensed plumber and all necessary repairs completed to Corrosion noted on the drain piping under the sink. A chip was noted in the sink. Have a licensed plumber replace the sink and drain piping BEFORE a leak develops.

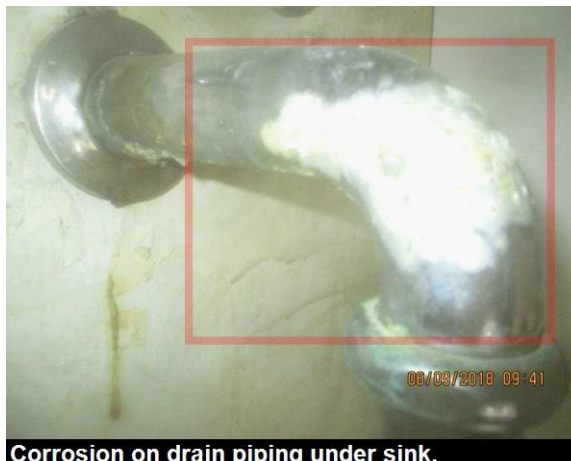
**Corrosion on drain piping under sink.**

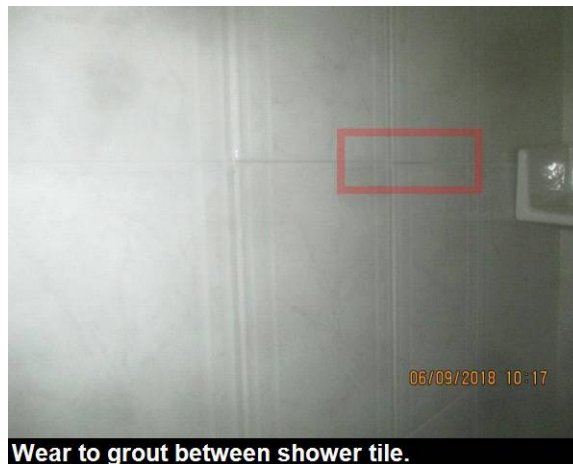
*Condition: Fixtures & Surround:* POOR. The grout, between the tile of the shower surround, is worn/deteriorated. The tiles should be re-grouted to prevent water penetration behind the tile surround. Corrosion noted on the drain piping under the sink. Have a licensed plumber replace the drain piping before a leak develops. The toilet tank lid is chipped. It will be difficult to replace the lid without replacing the whole toilet and tank. The sink stopper is NOT functional and should be repaired or replaced.

**Wear to grout between shower tile.**

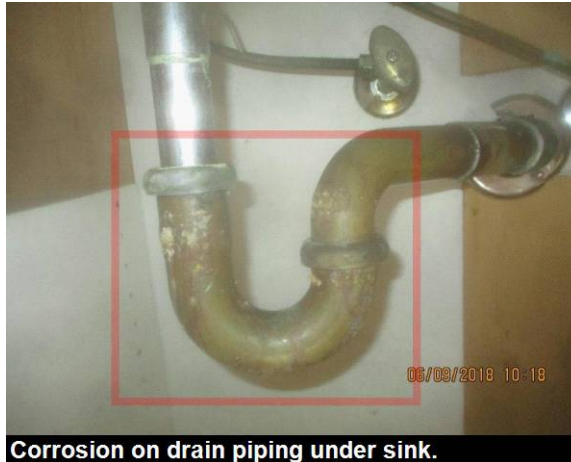
**Corrosion on drain piping under sink.**

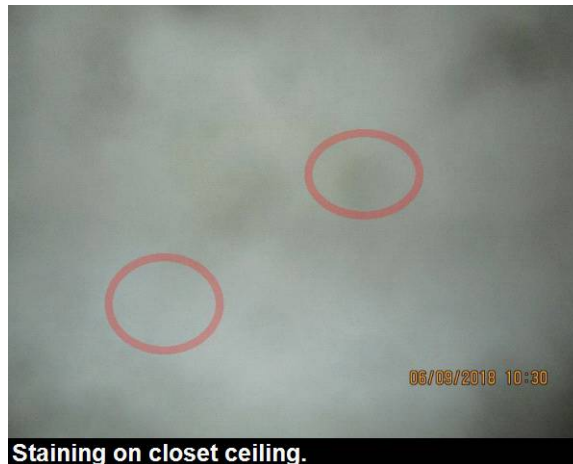
Staining on closet ceiling.

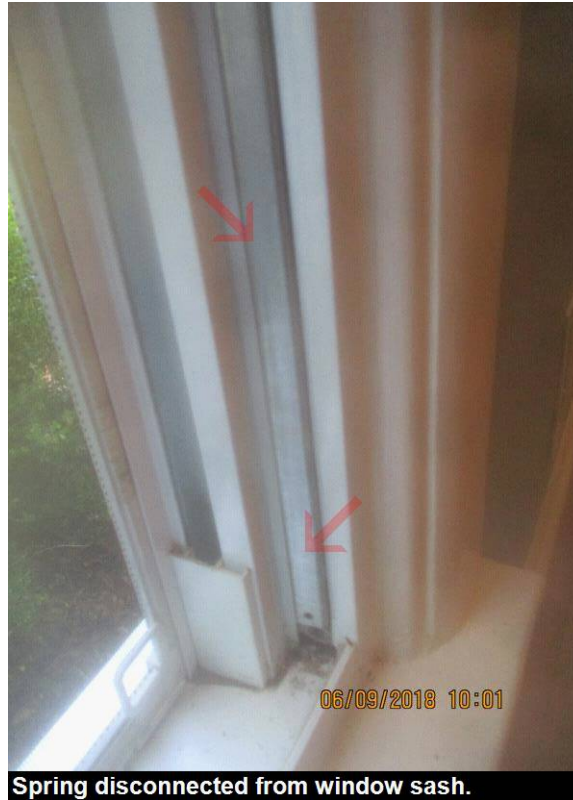
**Spring disconnected from window sash.**  
POOR. The center living room window is damaged (one of the springs is NOT functional and the bottom of the lower sash is damaged). Have this window repaired or replaced by a qualified contractor to restore proper operation. Note: It is advised to keep the vinyl windows locked, when closed, to reduce the potential for warping over time. The windows have been replaced approximately 12-13 years ago.

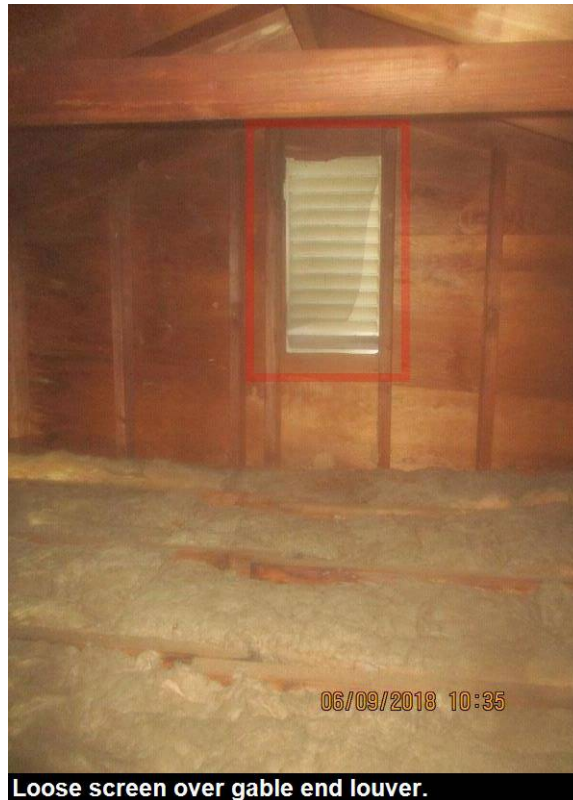
POOR. The screens, over the interior of the gable end louvers, should be secured to the louvers to prevent insect and rodent entry into the attic. The quantity of ventilation is marginal for modern construction standards. It is advised to have ridge and soffit venting installed when the roofing is replaced.

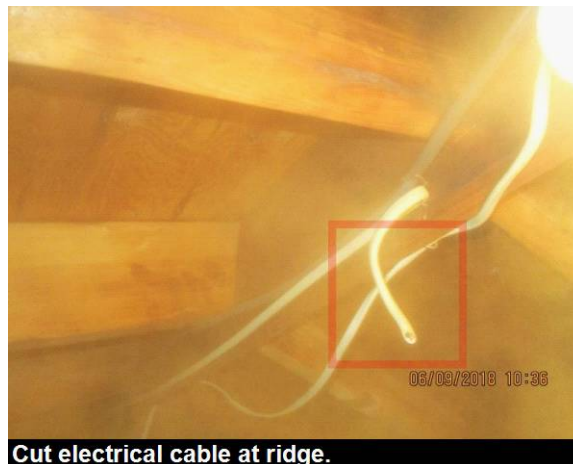
POOR. A cut non-metallic "Romex" type cable is located on the ridge at the left side of the attic. Have a licensed electrician cap these wires inside a junction box to improve safety.

Cut electrical cable at ridge.

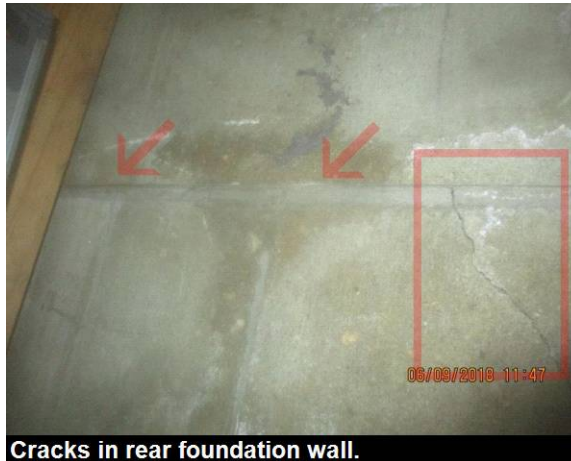
**Cracks in rear foundation wall.**

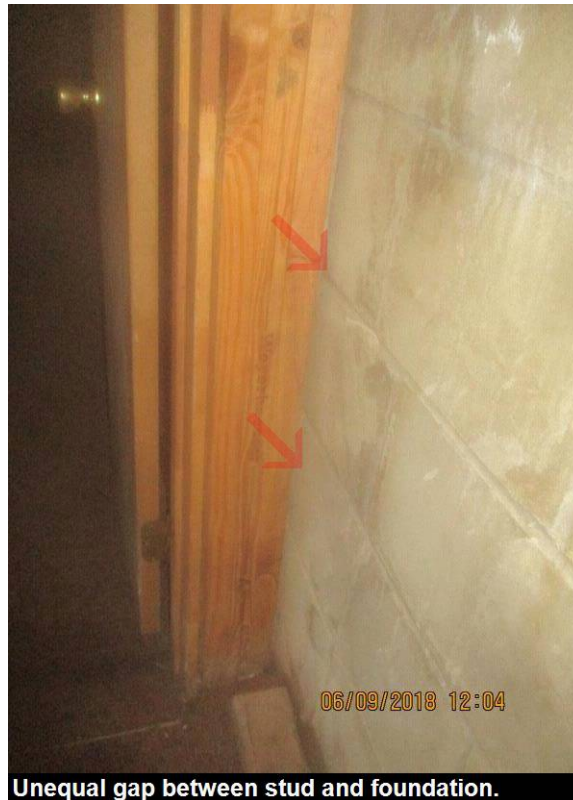
**Unequal gap between stud and foundation.**

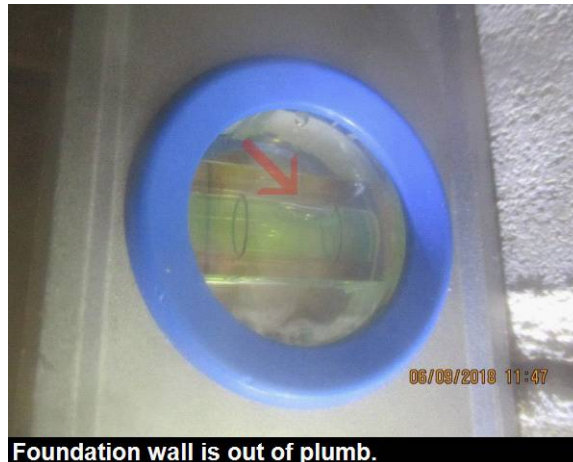
**Foundation wall is out of plumb.**

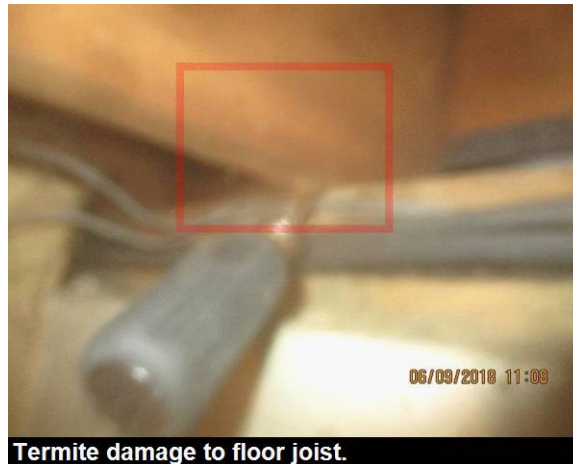
**Termite damage to floor joist.**

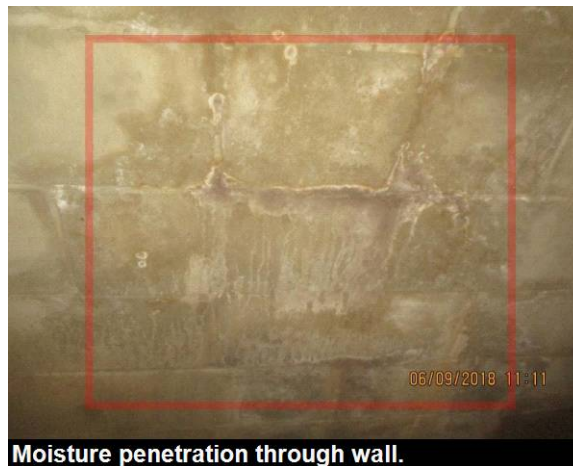
**Moisture penetration through wall.**

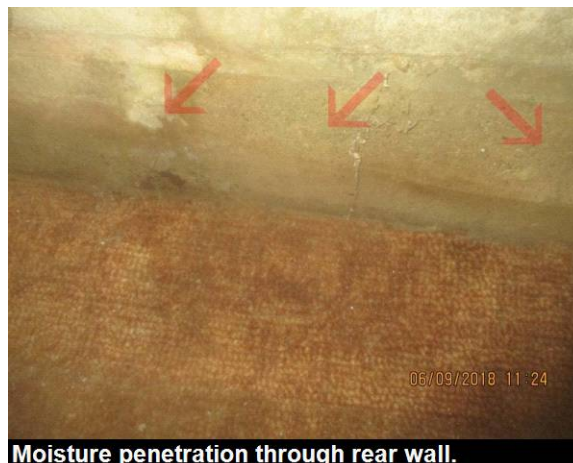
**Moisture penetration through rear wall.**

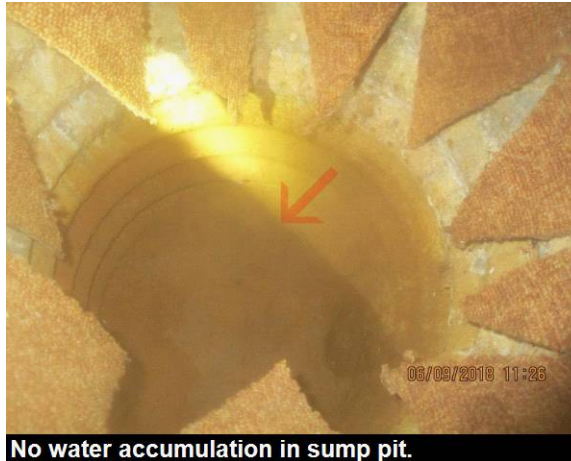
There was no water in the sump pit at the time of the inspection. A pump is NOT installed in the sump pit. The sump pit should be monitored for water accumulation and a licensed plumber should install a sump pump as needed.

**No water accumulation in sump pit.**

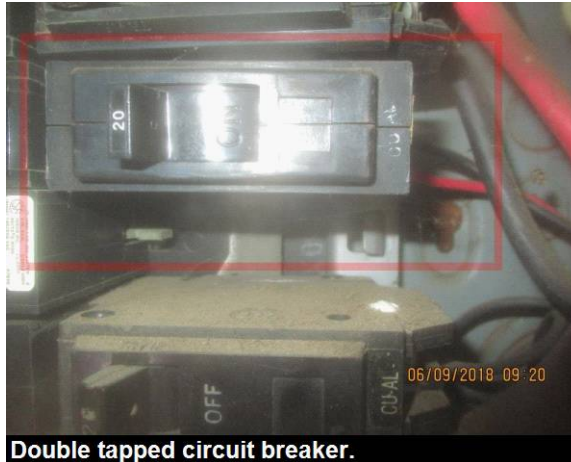
**Double tapped circuit breaker.**

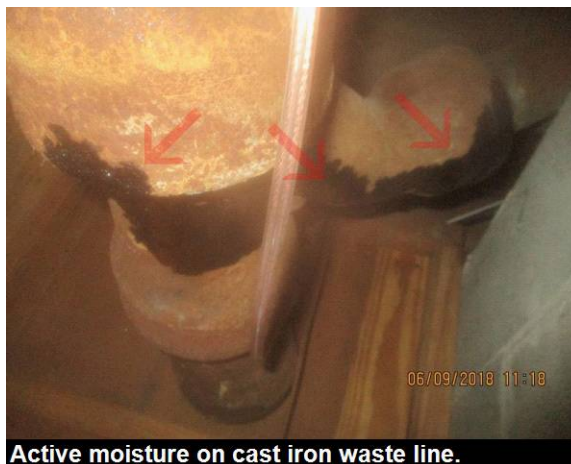
**Active moisture on cast iron waste line.**

*Condition:* POOR. Active staining noted on the original cast iron stack and sewer line at the right

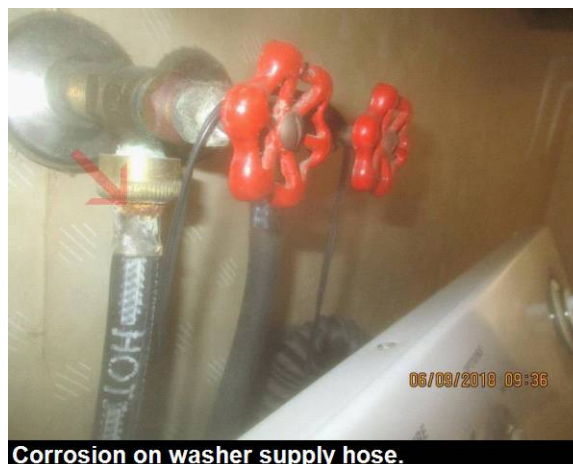
The washer was NOT tested as part of this home inspection. Operation of the washer should be tested PRIOR to closing. The washer is very old. Replacement should be planned. Corrosion noted on the ends of the washer supply hoses. The supply hoses should be replaced with braided steel lines to reduce the potential for leaks.

Corrosion on washer supply hose.

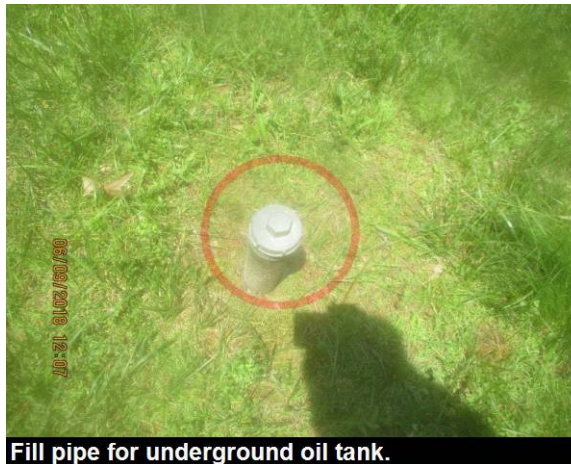
**Fill pipe for underground oil tank.**

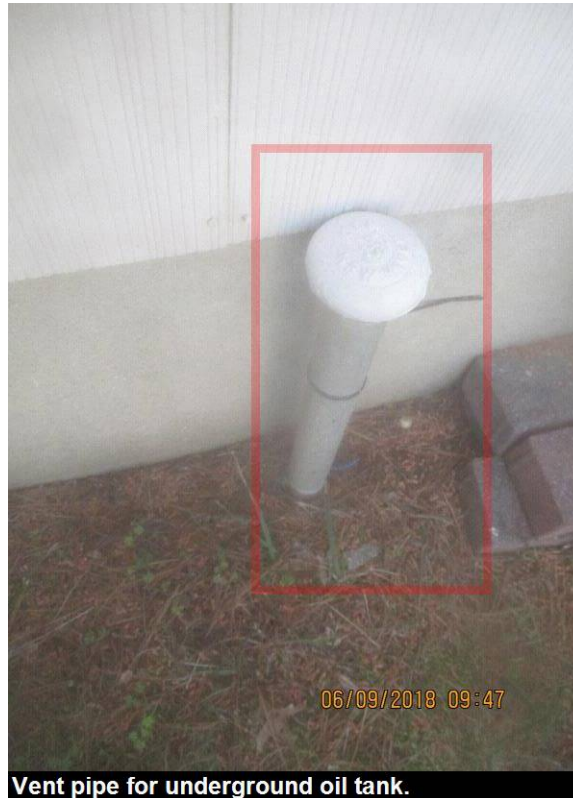
**Vent pipe for underground oil tank.**

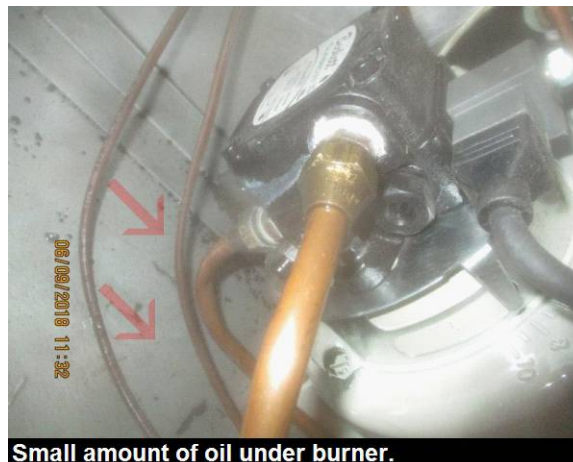
POOR. A small amount of heating oil was noted on the base of the furnace cabinet (under the oil burner). Have further evaluated by a qualified oil heating contractor and all necessary repairs completed. Fired normally when called by the thermostat. Safety controls, on the heating system, are NOT tested as part of a home inspection. The interior of the combustion chamber is NOT visible for inspection. Potential for deficiencies that are NOT visible for inspection. Annual servicing by a qualified oil heating contractor is advised to promote efficient and safe operation of the heating system.

**Small amount of oil under burner.**

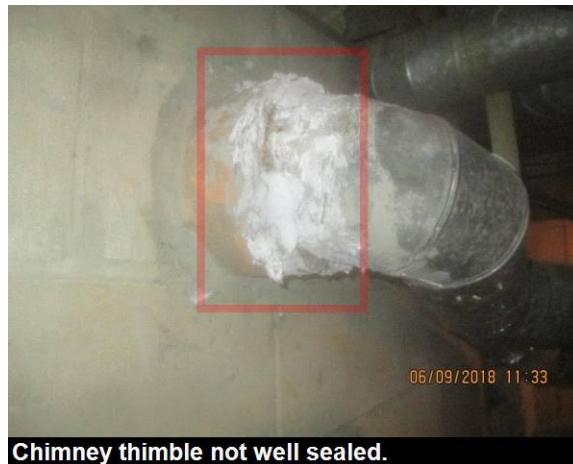
FAIR. Metal flue connector with masonry chimney. The flue connector is poorly sealed to the chimney thimble (connection of the flue to the masonry chimney). The flue connector should be properly sealed to improve safety (to reduce the potential for flue gas leakage into the basement). A rain cap should be installed on the top of the chimney flue to prevent water and possible pest entry into the chimney flue. There is NO visibility of the interior components of the chimney. It is highly recommended that chimneys used for oil fired appliances have a stainless steel liner installed by a qualified chimney contractor to reduce the potential for moisture damage and deterioration to the interior of the chimney flue. The potential exists that there could be damage inside the chimney that is not visible to the inspector.

Chimney thimble not well sealed.

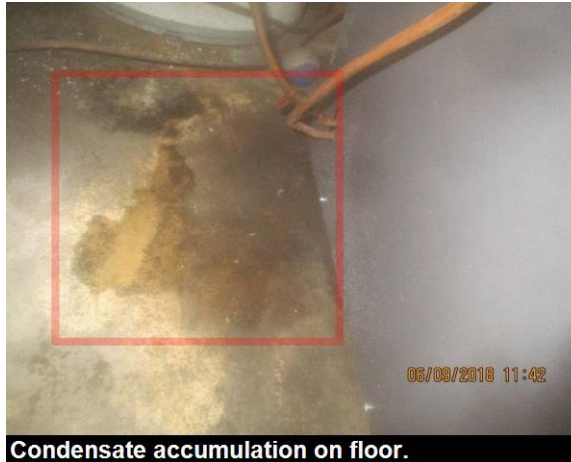
**Condensate accumulation on floor.**  
POOR. Although the temperature difference between supply and return was between 15 & 20 degrees which is considered normal, condensate is leaking from the plenum above the furnace (condensate drips onto the floor next to the furnace). The system is ORIGINAL to the house and WELL BEYOND ITS USEFUL LIFE. This system likely contains R22 refrigerant due to the age of the system. As R22 refrigerant will NO longer be manufactured, recharging the system will be VERY EXPENSIVE when the coil is replaced. Complete replacement of the system is advised. It is advised to maintain a service contract on the system with a qualified HVAC contractor.
