12 Howell Lane
Somerset, NJ 08873

Inspection reference: 020724JM1

Confidential Inspection Report
12 Howell Lane
Somerset NJ 08873

February 7, 2024

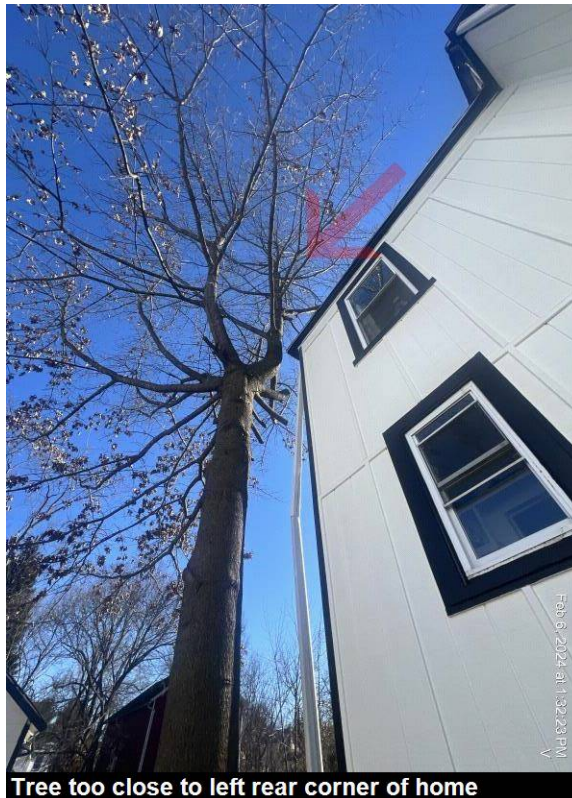
POOR. The tree, off the left rear corner of the home, is too close to the house. The branches are in close proximity to the flat roof. Have a qualified tree contractor remove the tree to reduce the potential for damage to the roof and foundation as well as reduce the potential for pest entry into the attic. Due to the season, the condition of most of the trees could NOT be determined. Monitor the property for dead trees and branches and have removed by a qualified tree contractor as needed. Note: Keep trees and shrubs trimmed away from the building. Monitor condition of trees and prune as needed.

Tree too close to left rear corner of home

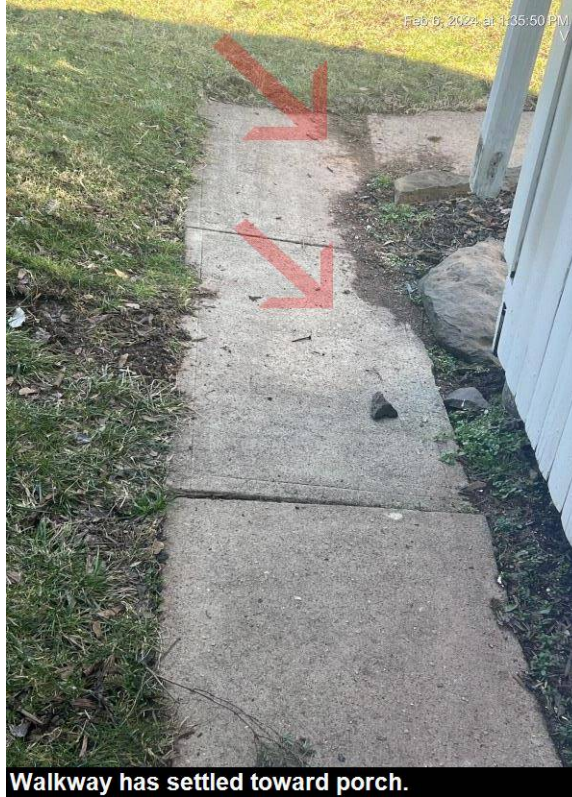
Walkway has settled toward porch.

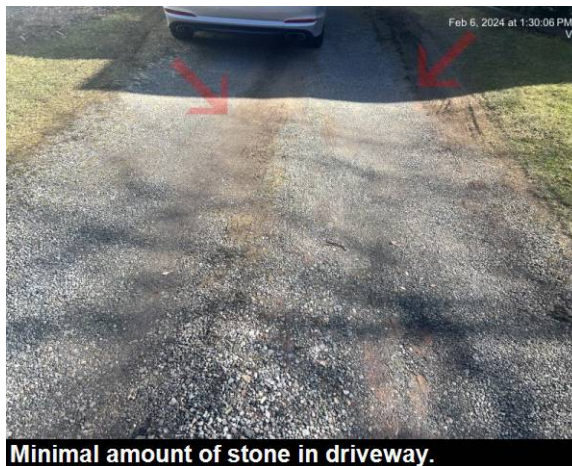
Minimal amount of stone in driveway.

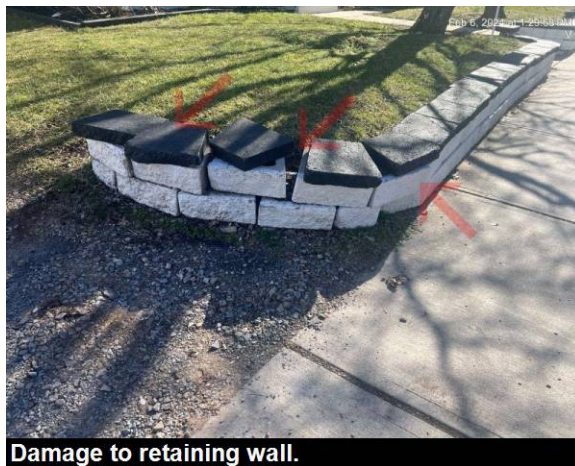
POOR. Several loose masonry blocks were observed in multiple areas of the retaining wall - around the front of the lot. Have a qualified mason contractor repair or replace the retaining wall to prevent erosion of the soil.

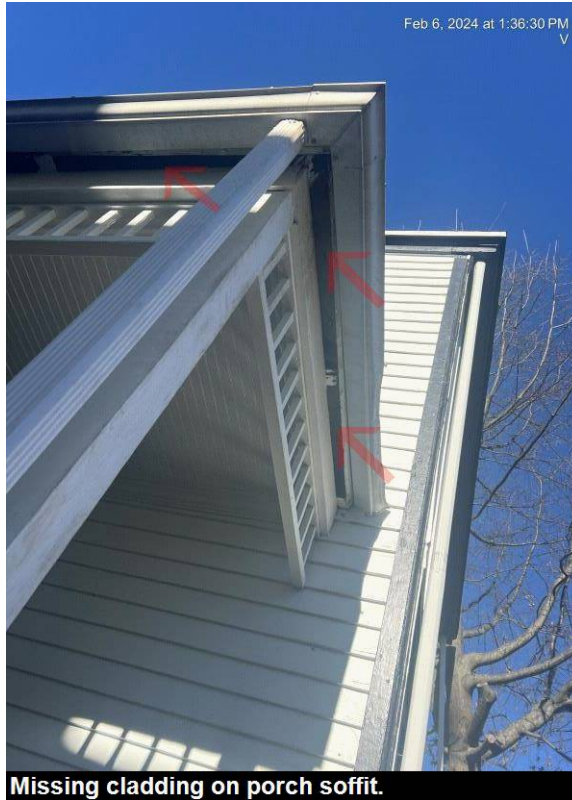
Missing cladding on porch soffit.

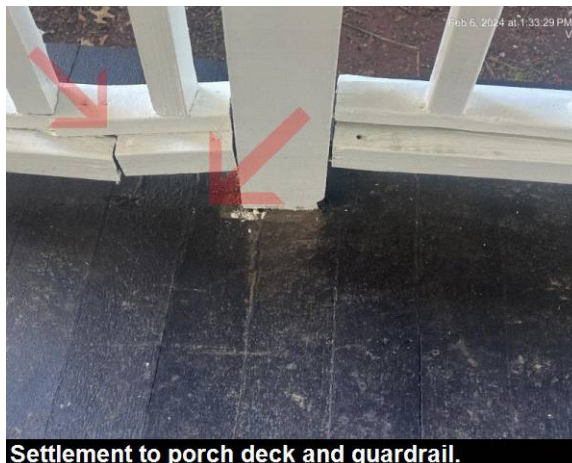
Settlement to porch deck and guardrail.

POOR. Significant settlement noted to the porch deck that extends along the right side of the home. The porch structure has also pulled away from the house. Trim has been installed over the gap between the porch decking and the walls of the home. The support posts penetrate the soil with NO visible evidence of footings (as visible from the basement windows). Some areas of the guardrail, around the perimeter of the porch, are loose. Wood plank cladding has been installed around the perimeter of the wraparound porch. The majority of the framing, under the porch, is NOT visible for inspection. Potential for further damage/deterioration to exist that is NOT visible for inspection. This long wraparound porch requires major repairs and reinforcement at this time. Consult qualified contractors for estimates for major repairs/reinforcement or complete replacement PRIOR to closing. The steps, that lead up to the porch, have been constructed with open risers. Have a qualified contractor enclose the open risers to improve safety.

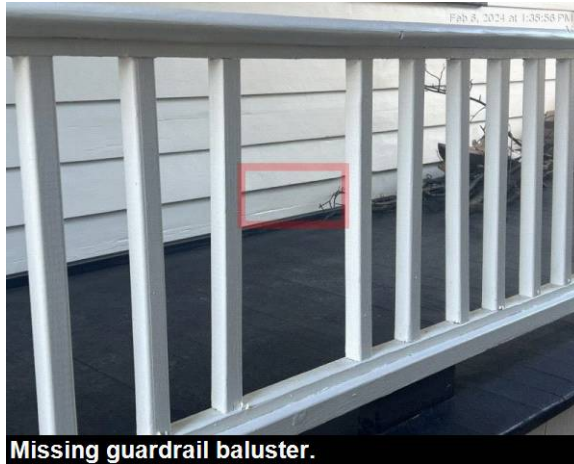
Missing guardrail baluster.

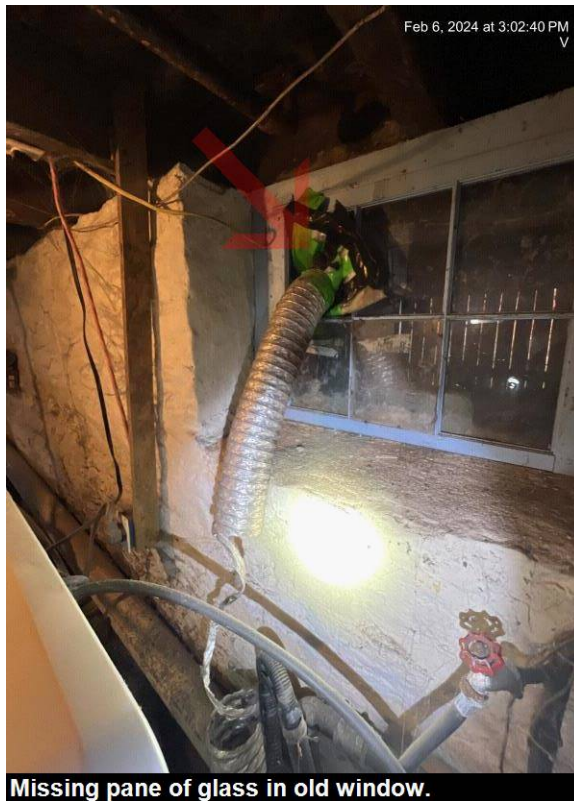
POOR. A glass pane is missing from the right front basement window (the pane was removed when the older dryer exhaust duct was run through the window). Have a qualified contractor replace the missing glass pane to reduce the potential for pest entry into the home.

Missing pane of glass in old window.

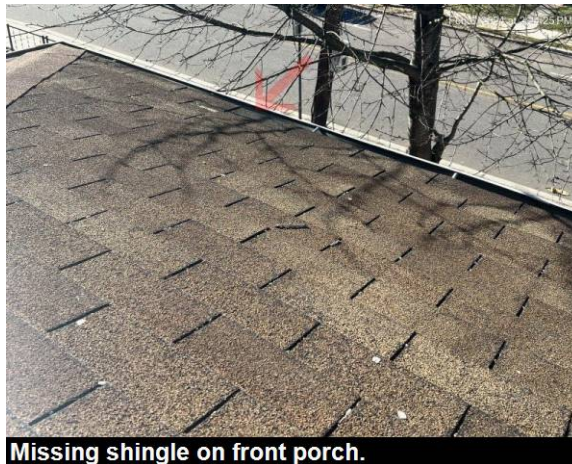
Missing shingle on front porch.

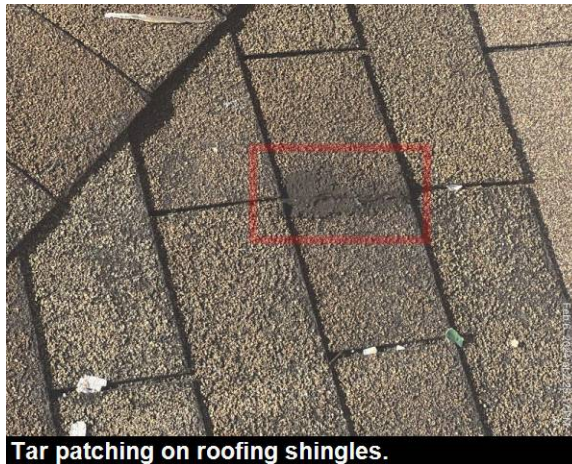
Tar patching on roofing shingles.

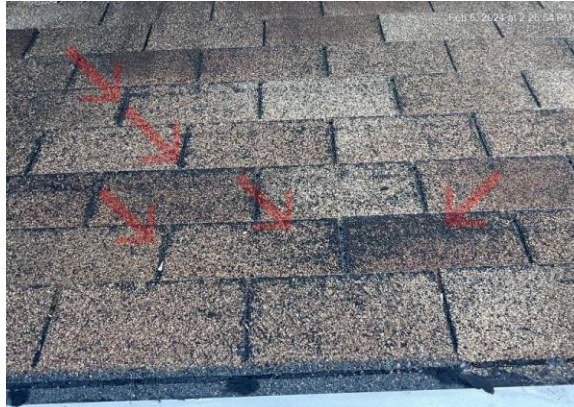
Asphalt granule loss to shingles.

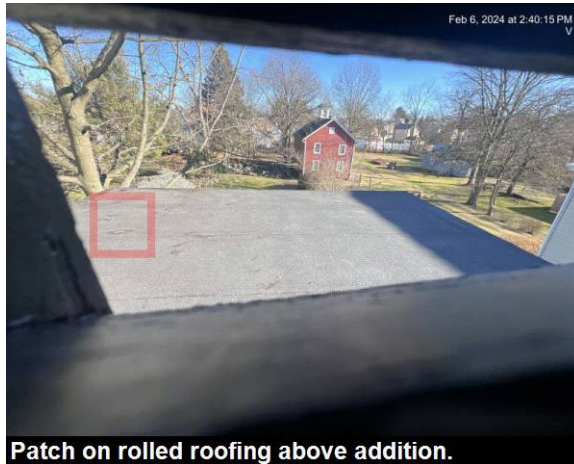
Patch on rolled roofing above addition.

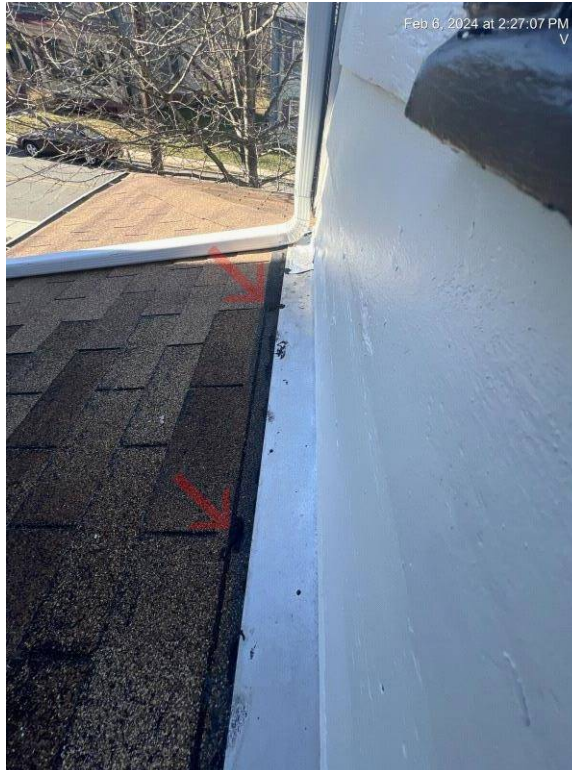
Flashing does NOT cover roofing nails.

POOR. The flashings, along the upper edges of the lower roof decks, do not cover nails in the shingles (there is too much shingle exposure which can be conducive to leaks). Tar patching was noted on the original brick chimney. Light is visible around the chimney - as noted from the attic. All flashings should be replaced along with the roofing - to prevent leaks from occurring around the roof penetrations.

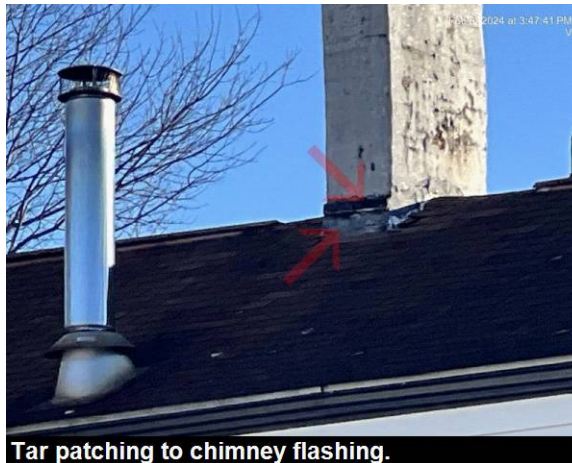
Tar patching to chimney flashing.

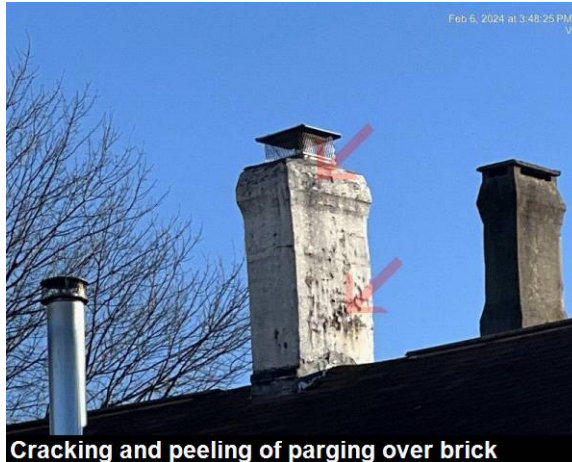
Cracking and peeling of parging over brick

POOR. Cracking and peeling of the parging material that has been applied over the brick. Tar patching noted on the chimney flashing. Light is visible around the chimney - as noted from the attic. Spalling and deterioration noted to multiple bricks as well as the mortar as visible from the attic. Consult a qualified chimney contractor for all necessary repairs PRIOR to closing. Exterior evaluation only. The interior of the chimney is NOT inspected. See the Fireplace section of the report for further information.

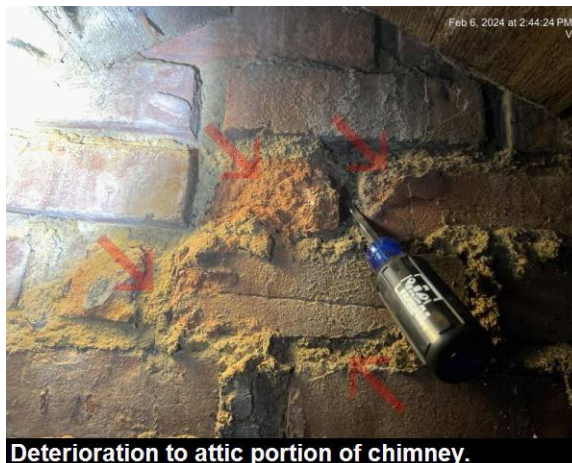
Deterioration to attic portion of chimney.

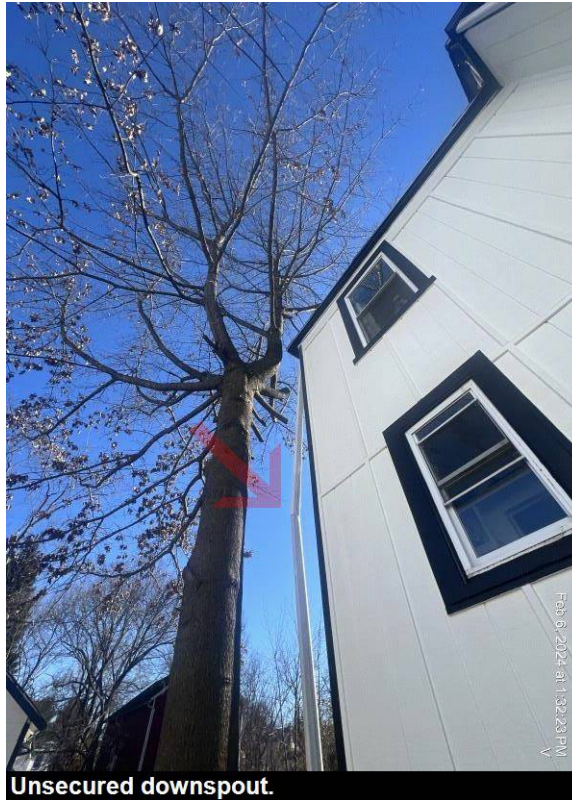
Unsecured downspout.

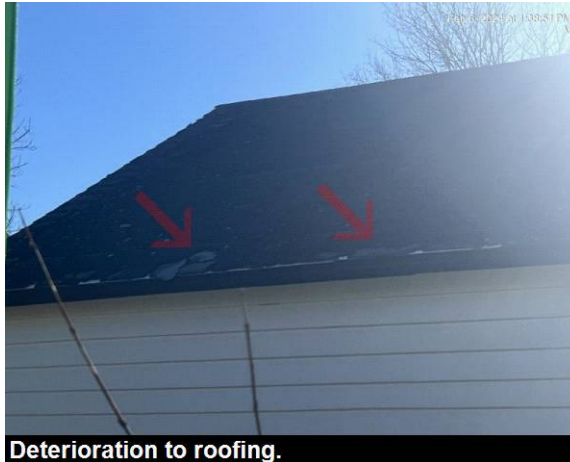
Deterioration to roofing.

Overall condition: POOR. The roofing shingles are worn and in deteriorated condition. The roofing requires replacement at this time. Obtain estimates, from qualified roofing contractors, for replacement PRIOR to closing.

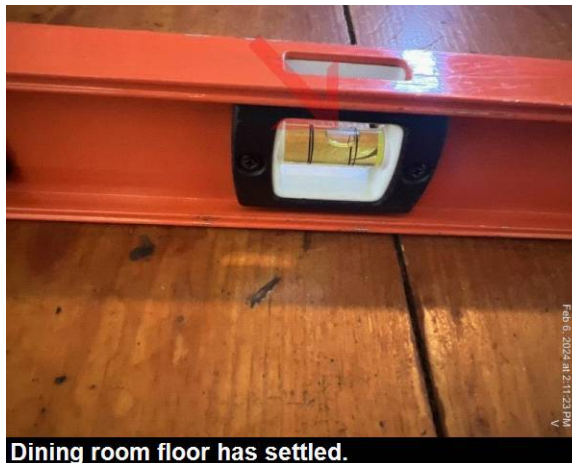
Dining room floor has settled.

POOR. Settlement noted to the floors in the dining room, living room and front second story bedroom. See the Basement and Attic sections of the report for need for further evaluation and structural reinforcement.

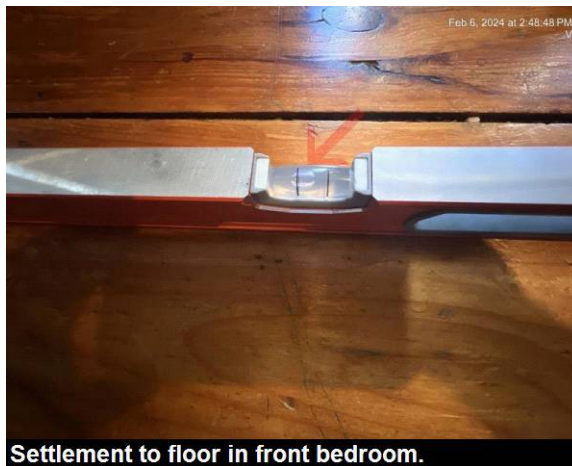
Settlement to floor in front bedroom.

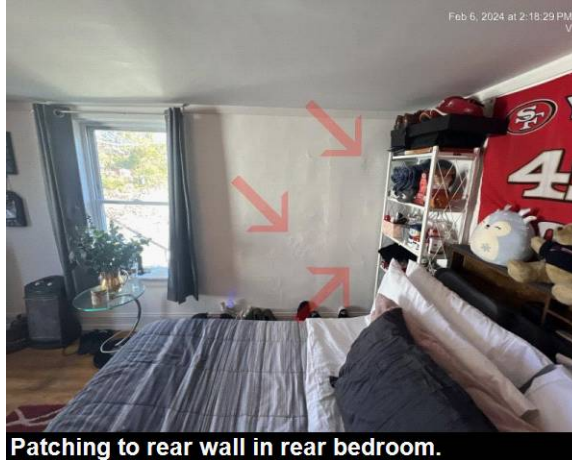
Patching to rear wall in rear bedroom.

FAIR. Extensive patching was noted to the rear wall of the rear bedroom. The patched areas of the wall tested dry with a moisture meter. Obtain history of possible leaks and patching to this wall from the owner PRIOR to closing. Cracks noted to the plaster walls in multiple locations of this home - especially on the second story. As the plaster ages, additional cracks will likely develop. Plan on replacement of the plaster with drywall.

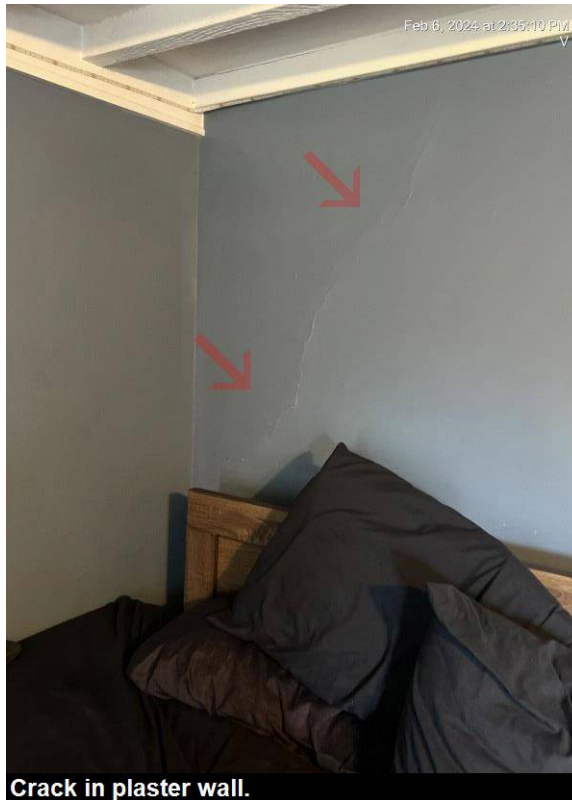
Crack in plaster wall.

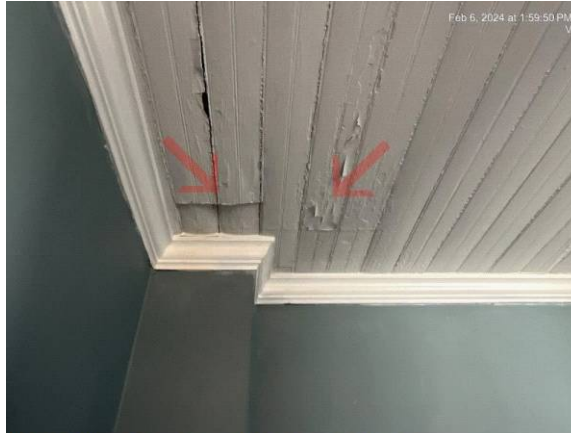
Moisture damage to kitchen ceiling.

POOR. Moisture damage noted to the bead board ceiling in the kitchen (right front corner of the kitchen near the chase for the piping that runs to the second story bathroom). See the Plumbing section of the report for further information in regard to leaks from the plumbing vent stack that runs in this area. The ceiling joists, in the front second story bedroom, have sagged - toward the center of the span. The joists, at the front of this bedroom, have been cut to form a dormer. This may have contributed to the deflection of the ceiling joists. Have further evaluated by a qualified structural contractor and any necessary reinforcement performed to prevent further deflection from occurring.

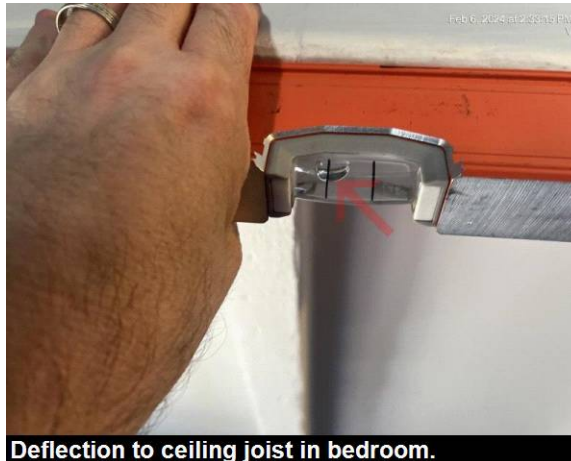
Deflection to ceiling joist in bedroom.

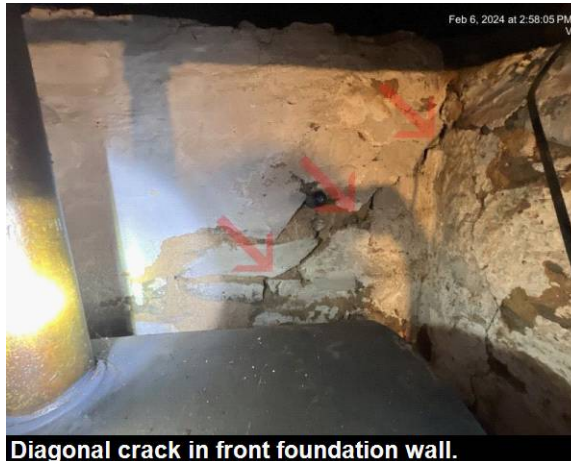
Diagonal crack in front foundation wall.

Foundation system: Condition & POOR. A diagonal crack was noted in the left corner of the front foundation wall (above and behind the oil tank). Deterioration noted to the mortar joints between the stones within the foundation walls (visible where the concrete parging has worn off the walls). Have the foundation further evaluated by a qualified structural mason contractor to determine best means of repair and reinforcement.

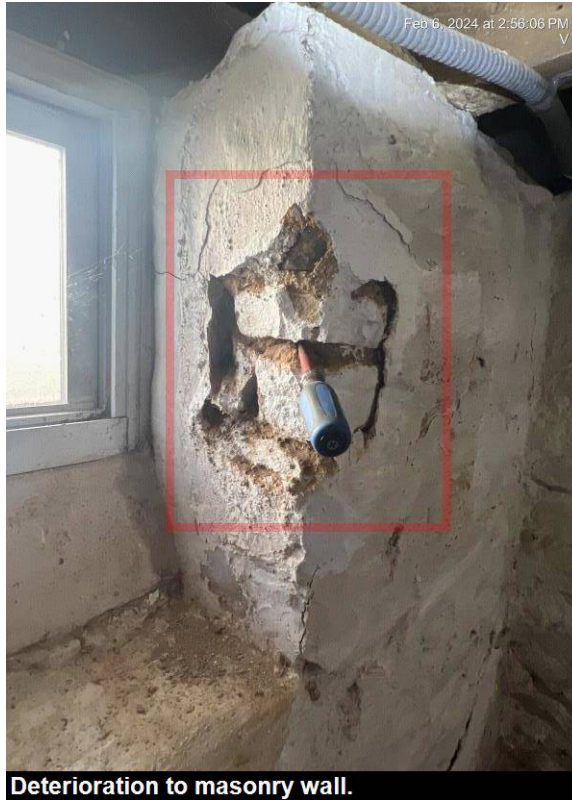
Deterioration to masonry wall.

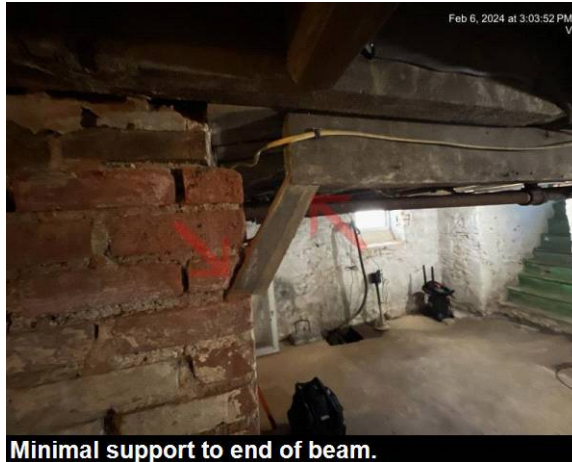
Minimal support to end of beam.

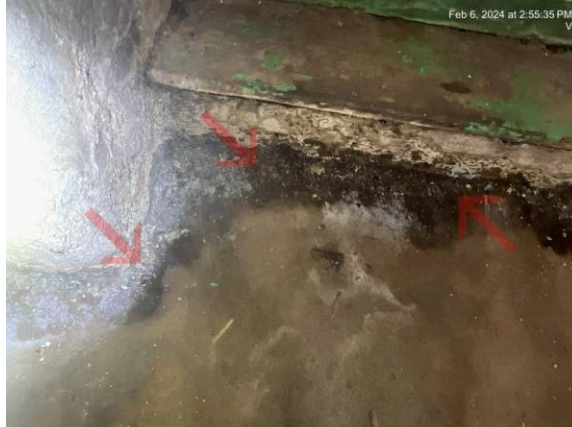
Staining around base of staircase.

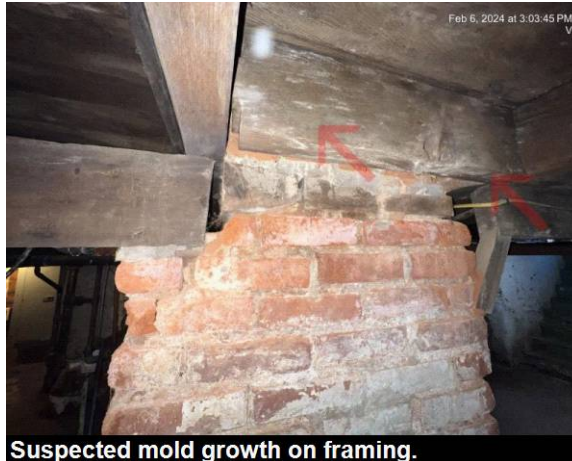
Suspected mold growth on framing.

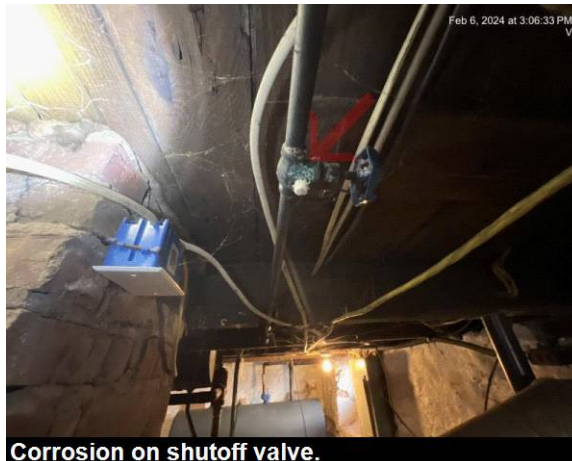
Material: Copper.
Condition: POOR. Corrosion noted on multiple shutoff valves throughout the basement. Some of the copper supply lines are NOT adequately supported. Unprofessional piping supplies water to the clothes washer. Have a licensed plumber replace all corroded shutoff valves and replace all unprofessional supply piping BEFORE leaks can develop.

Corrosion on shutoff valve.

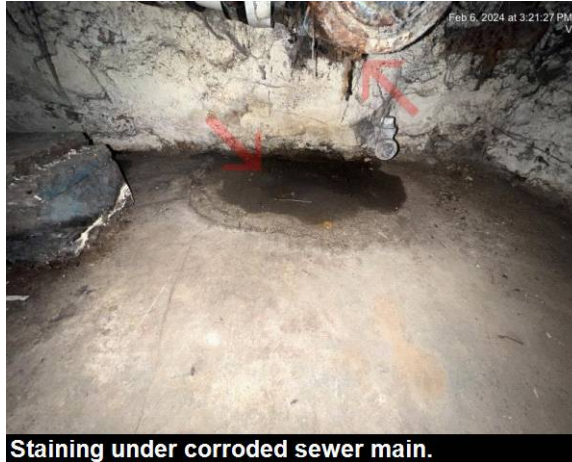
Staining under corroded sewer main.

POOR. Corrosion and extensive leakage noted around the plumbing waste stack located in the crawlspace. Staining was also noted under the main sewer line penetration through the foundation wall. Multiple small sections of PVC piping have been patched into the main sewer line. This can be conducive for leaks to develop. The main plumbing vent stack terminates in the attic. This can result in sewer gas odors and the accumulation of sewer gas in the attic. Have a licensed plumber make all necessary repairs and replace the remaining cast iron piping to prevent additional leaks from developing. The main sewer line is likely 100+ years old. Underground pipes are NOT visible for inspection. Potential for blockage/repair exists. Due to the age of the piping, it is advised to have a licensed plumber conduct a camera scan of the underground sewer line to determine condition PRIOR to closing. Any damaged sections of piping should be replaced by a licensed plumber as needed.

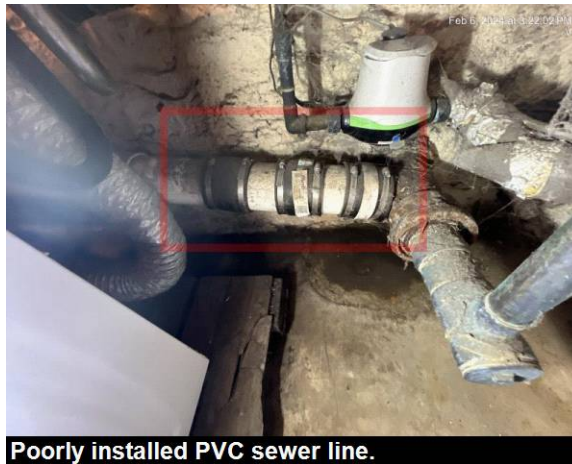
Poorly installed PVC sewer line.

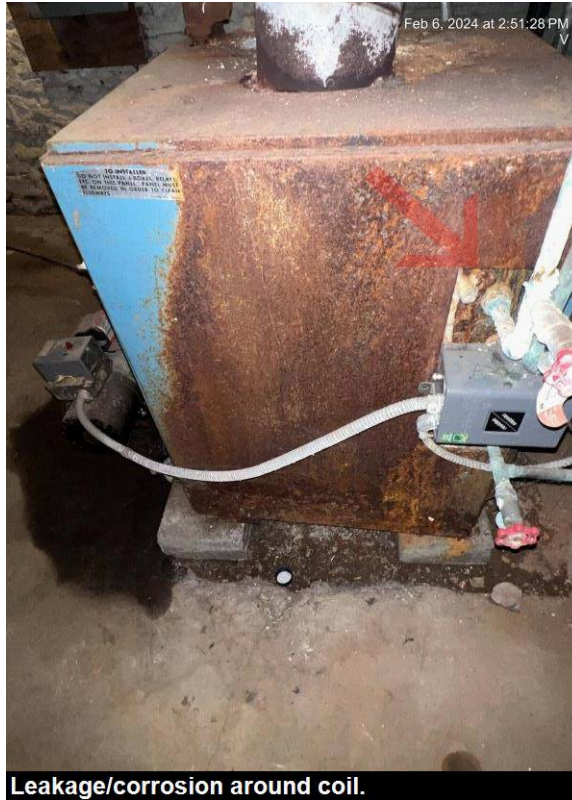
Leakage/corrosion around coil.

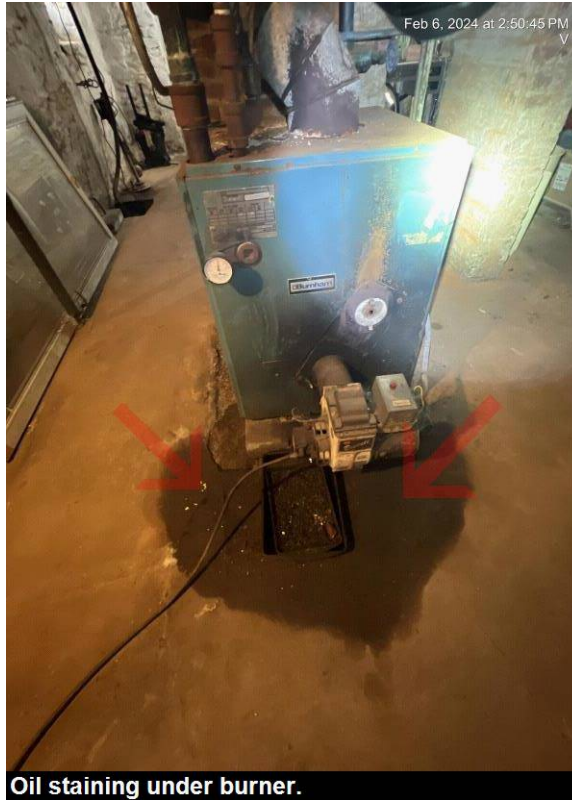
Oil staining under burner.

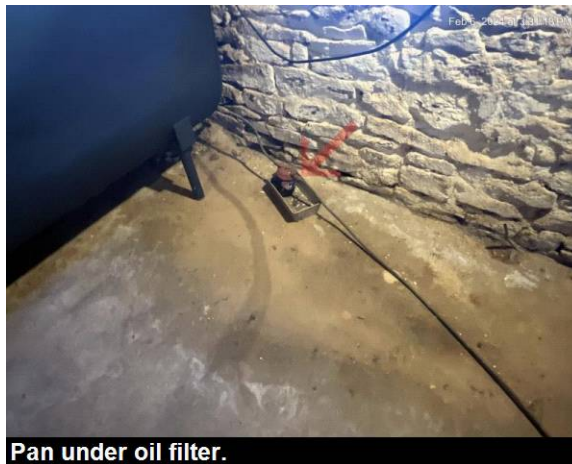
Pan under oil filter.

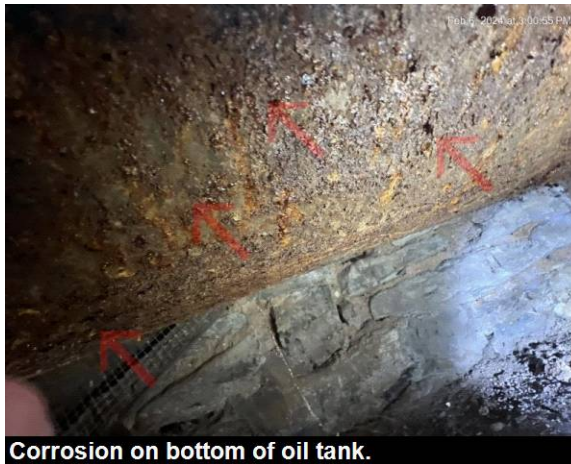
Oil tank is located in the basement. Oil tank insurance should be obtained and maintained. Extensive corrosion noted on the bottom of the steel tank (the sides of the tank have been more recently painted). Two of the tank legs are badly corroded. Have a licensed plumbing and heating contractor should be replaced BEFORE oil leakage occurs. It is advised to replace the current tank with a "Roth" type double walled tank to reduce the potential for oil leaks. A second oil line (which has been cut) terminates near the left side foundation wall. The inspector makes NO deliberate attempt to locate potential underground fuel storage tanks. Due to the environmental concerns associated with underground fuel storage tanks, HIGHLY recommend having a qualified environmental contractor conduct an underground tank search PRIOR to closing. Any tank(s), that may be located, should be professionally removed with all necessary permits and permit approvals PRIOR to closing.

Corrosion on bottom of oil tank.

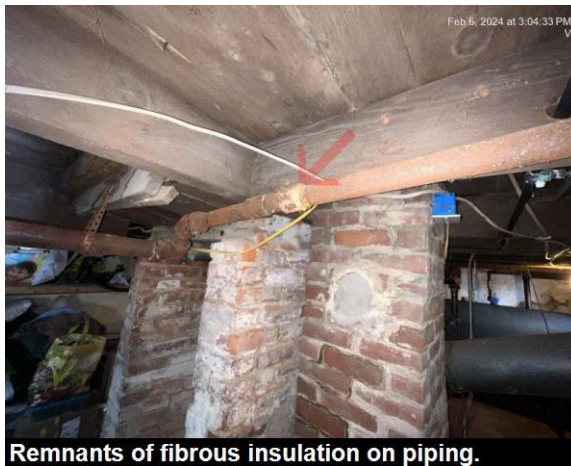
Remnants of fibrous insulation on piping.
