1054 W. Chestnut St
Middletown, NJ 07748

Inspection reference: 112523JM2

Confidential Inspection Report

January 10, 2026

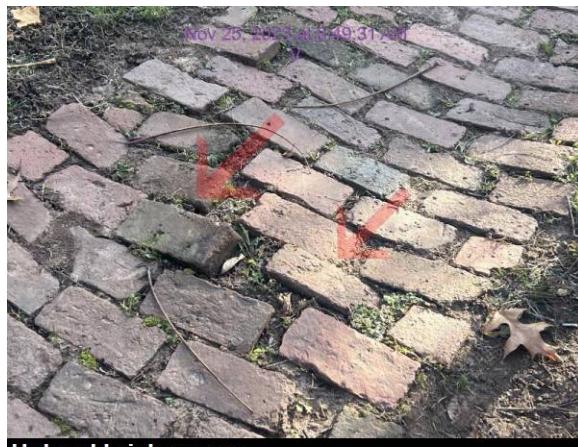
Unlevel brick pavers.

POOR. Uneven and unlevel brick pavers present a potential trip hazard. Have a qualified paving contractor level the pavers or replace the walkway to improve safety. The concrete stepped walkway, that leads down to the bridge and stream, is cracked and poorly supported. This presents the potential for injury. This stepped walkway requires replacement at this time. Consult a qualified mason contractor to replace this walkway to improve safety.

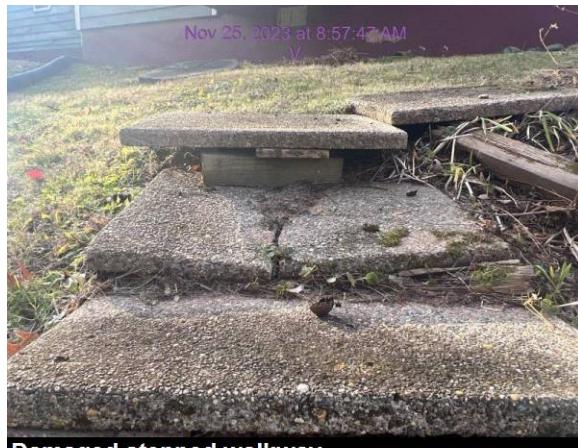
Damaged stepped walkway.

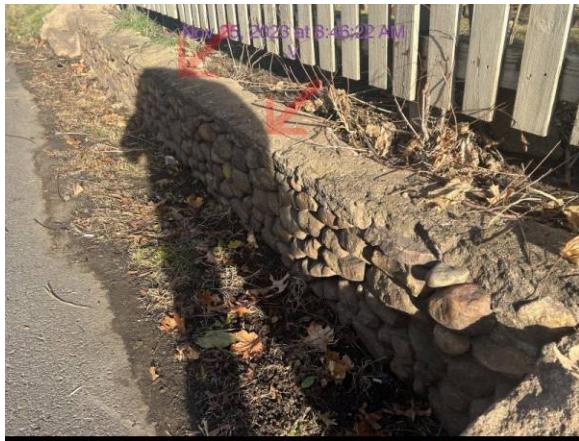
Stone wall leaning away from property.

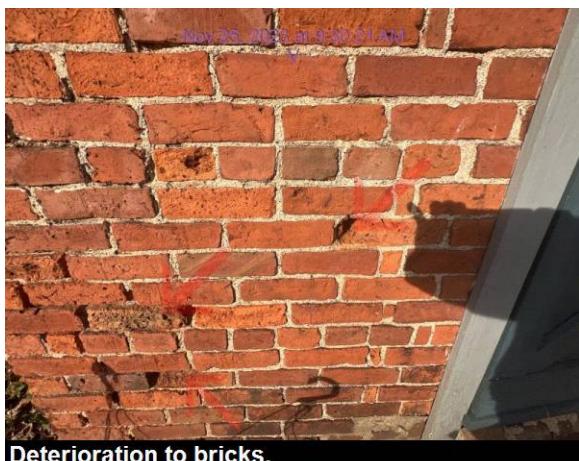
POOR. Deterioration to multiple bricks that comprise the small brick shed at the right rear corner of the lot (just above the stream). This small building has been constructed near the upper stream bank and likely has NOT been constructed on a footing. Have a qualified contractor make all necessary repairs to prevent further deterioration to the masonry. Monitor for erosion of the soil, between this structure and the stream, and have a qualified mason contractor install a retaining wall as needed. The wood framed shed, located at the left front area of the lot, was locked and could not be entered for inspection. The key should be obtained and the interior of this shed evaluated PRIOR to closing.

Deterioration to bricks.

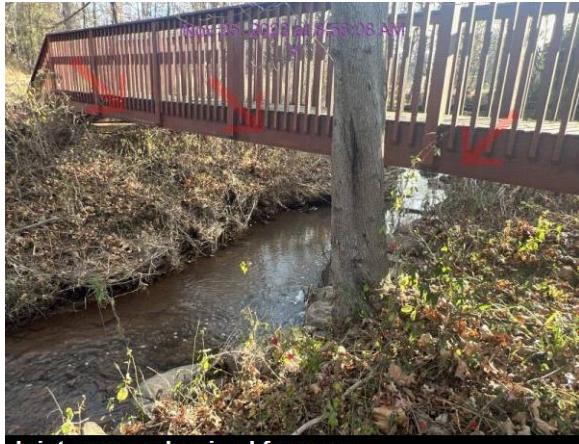
POOR. Deflection and vibration can be felt to the bridge deck that extends over the stream located behind the home. The joists, that support the decking, are undersized for their span. Have a qualified contractor reinforce the bridge span to improve safety.

Joists are undersized for span.

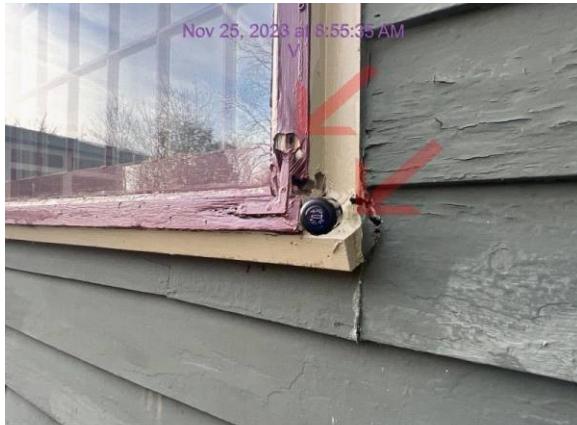
Rot and deflection to large window sill.

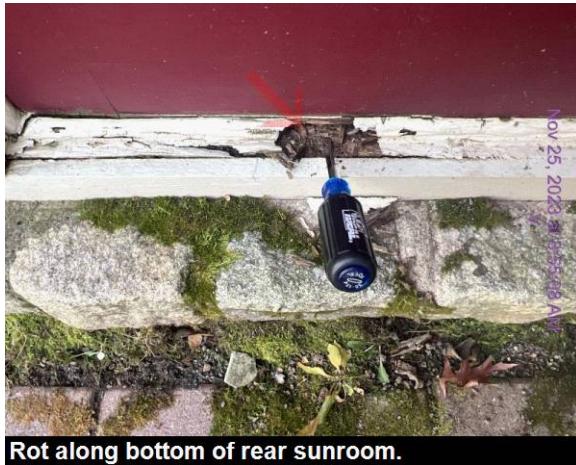
Rot along bottom of rear sunroom.

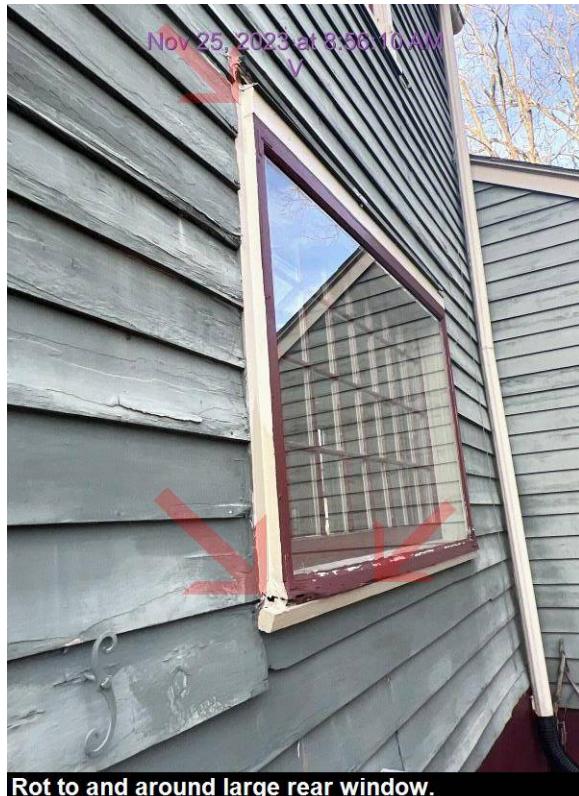
WINDOWS: Extensive rot and settlement noted to the large rear wood framed window as well as the sill under this window. Cracks noted to the plaster on the interior of this wall (under this fixed sash window). There is the strong potential for framing damage to exist in this wall cavity. Have a qualified contractor remove the siding from around this window and evaluate the framing for suspected damage PRIOR to closing. All damaged framing should be replaced as and where needed. Rot noted to the majority of the windows. Cracked glass panes noted in many of the windows. The majority of the windows are original to the home (over 200 years old) and require replacement at this time. Most of the windows are painted shut and can NOT be opened. Inoperable windows can prevent emergency egress in the event of a fire in the home. Peeling and chipped paint, on the various windows and sills, can contain lead - due to the age of the home. This presents a health safety concern. All of the windows should be replaced to provide proper operation and improve safety. Consult qualified contractors for estimates for replacement of all windows PRIOR to closing. Due to the age of the home, the framed window openings are no longer square. This will likely increase the cost of window replacement.

Rot to and around large rear window.

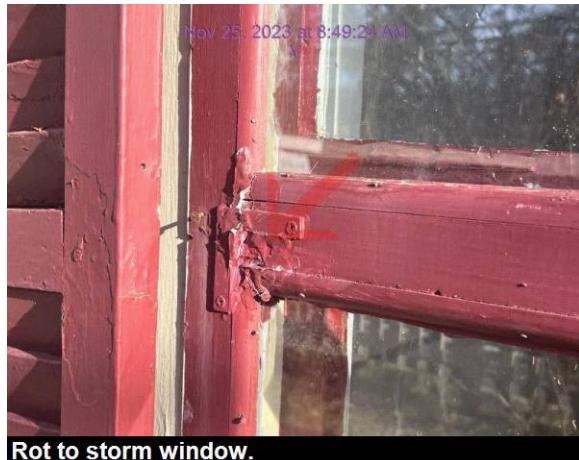
Rot to storm window.

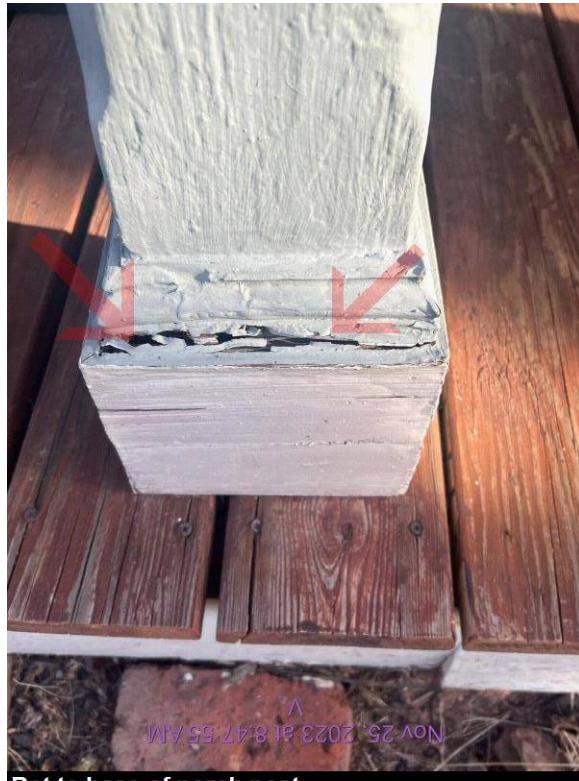
PORCHES AND STEPS TO BUILDING: Rot noted to the base of the support posts on the front wood framed porch. Have a qualified contractor replace these posts to properly support the roof above this porch. The concrete stoop, that provides access to the front entrance door to the left side addition, has settled back toward the building. This can result in standing water accumulation on the landing. Have repaired by a qualified mason contractor.

Rot to base of porch post.

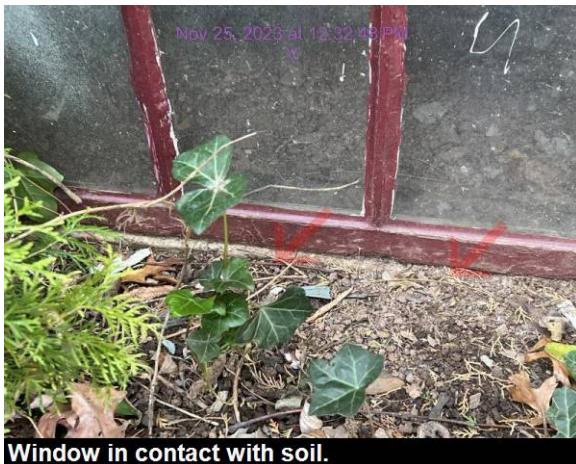
POOR. The windows are in contact with the grade of the soil. This is conducive to rot and wood destroying insect damage. Have a qualified landscape contractor install window wells and well covers to prevent further wood to soil contact.

Window in contact with soil.

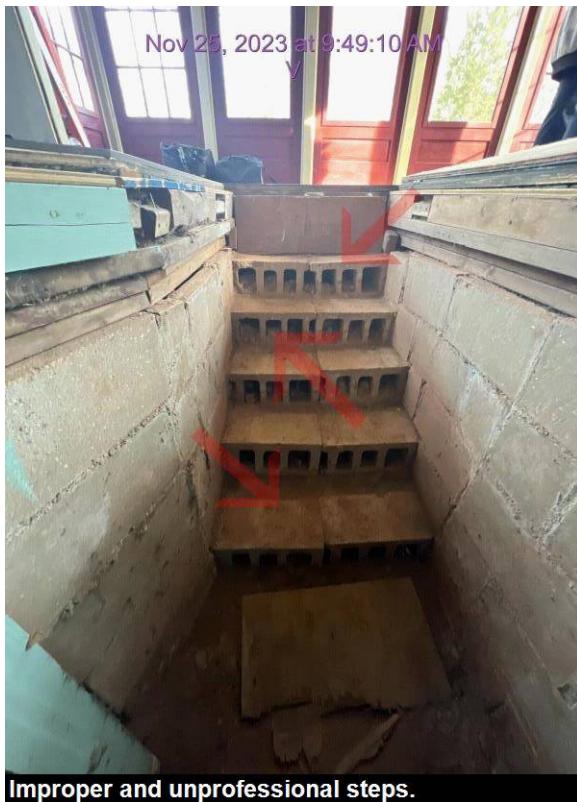
BASEMENT WALKOUT: The masonry block walkout foundation has been poorly constructed. Movement noted to the masonry block walls. The masonry blocks, that comprise the steps, have been installed in the wrong orientation (the blocks have been laid on their side). The posts, that support the door framing, rest in the soil. This walkout has been constructed in a very unprofessional manner. Have a qualified mason contractor replace the walkout foundation and steps to improve safety.

Improper and unprofessional steps.

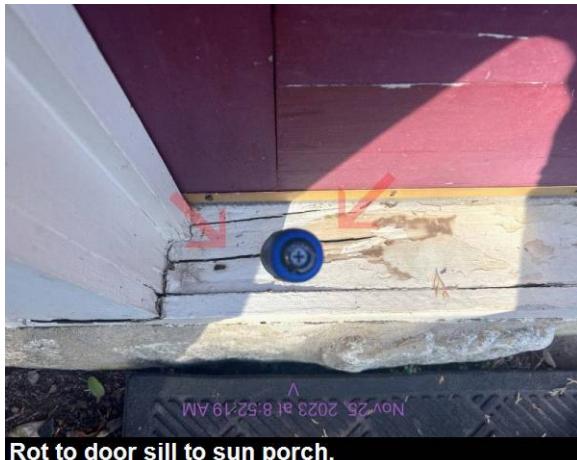
POOR. Extensive rot noted to the framing around the base of the rear enclosed porch/patio (rot was observed to the majority of the framing around the perimeter of this room). Rot also noted to the soffits under the roof overhangs. Have a qualified contractor replace all rotted framing and soffit trim/cladding.

Rot to door sill to sun porch.

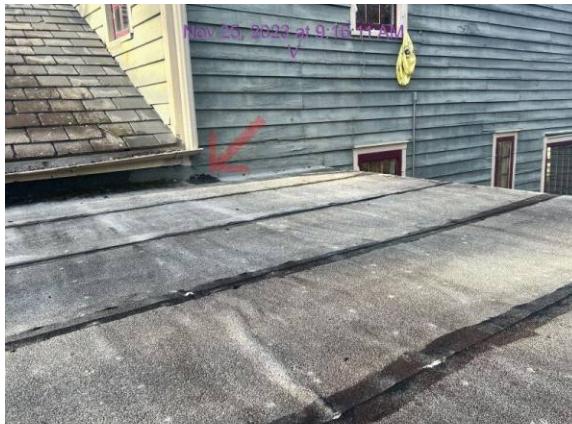
ADDITIONAL ROOFING: Extensive staining runs down the siding on the wood siding on the rear wall of the sunroom. Tar patching was noted to the roofing above this area. This should NOT be considered a proper and permanent repair. Rolled asphalt roofing is considered a low quality roofing product with a limited lifespan. Complete replacement of this roofing is advised to prevent suspected recurring leaks. The roofing, on the flat roof deck above the right front two story window bay, was NOT visible for inspection. However, staining and repainting was noted to the ceiling in the bathroom (where the flat roof meets the front wall of the home). Although currently dry, recurring leaks are suspected in this area. Have the roofing, above the bay, evaluated by a qualified roofing contractor and this roofing replaced and/or other repairs completed as needed.

Tar patching above sunroom roof.

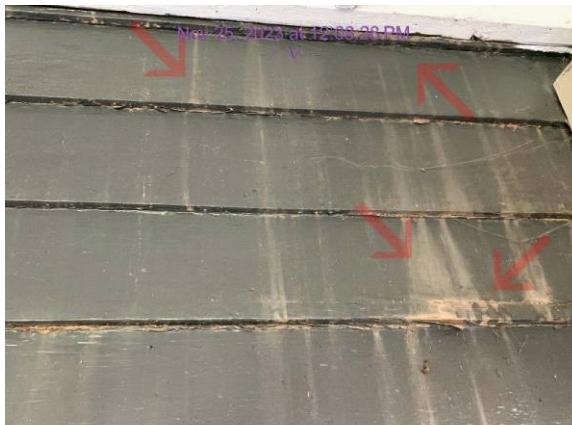
Staining on rear wall of sun porch.

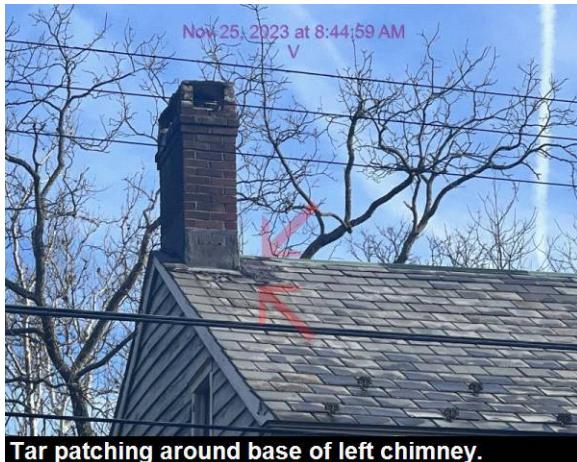
Tar patching around base of left chimney.

POOR. Use of tar noted on the slate around the base of both chimneys. Both chimney flashing have been patched with roofing tar. This should NOT be considered a proper and permanent repair. Leaks will likely redevelop once the tar dries out over time. Have a qualified slate roofing contractor replace both chimney flashings to prevent a recurring leakage.

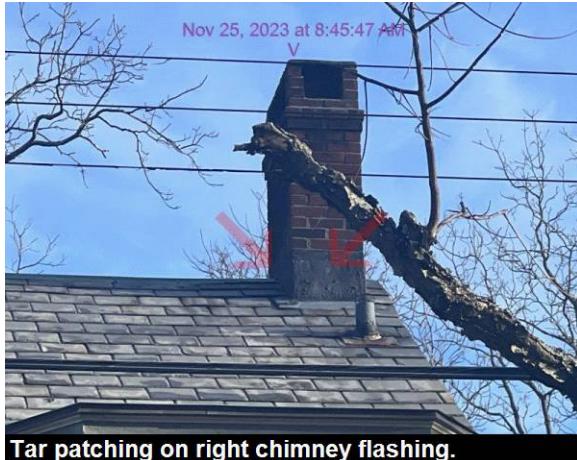
Tar patching on right chimney flashing.

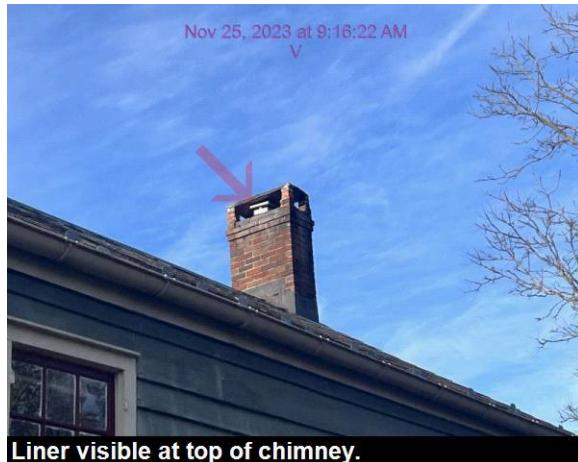
Liner visible at top of chimney.

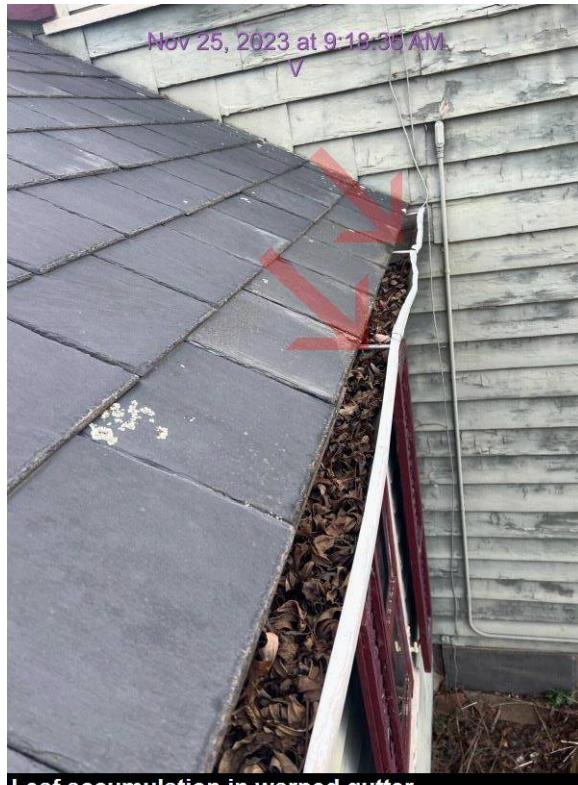
GUTTERS AND DOWNSPOUTS: Warped gutters and downspouts noted in various areas. This can result in overflow of roof surface runoff and water accumulation along the foundation. Have a qualified contractor replace all damaged gutters and downspouts to direct roof surface runoff away from the house. Leaf accumulation noted in the visible portions of the gutters. The gutters should be cleaned to promote proper drainage of roof surface runoff away from the house.

Leaf accumulation in warped gutter.

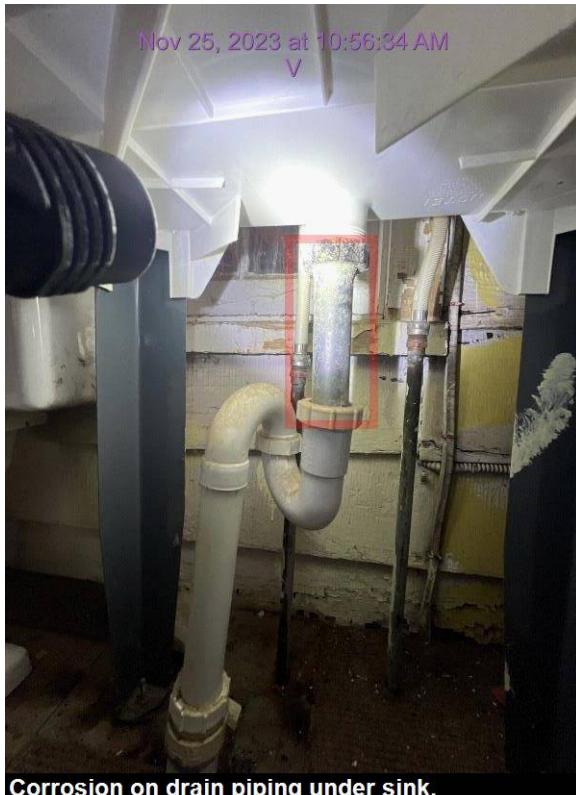
Condition: Fixtures & Surround: POOR. A toilet is located in the rear laundry room. There is NO source of heat in this laundry room . As such, there is the strong potential for the plumbing to the toilet, sink and washer to freeze during cold winter weather conditions. Have a licensed HVAC contractor install a source of heating in this room PRIOR to closing. The sink faucet drips when in the off position. Corrosion noted to the drain piping under the sink. The sink legs are NOT secured to the floor. Have a licensed plumber make all necessary repairs.

Corrosion on drain piping under sink.

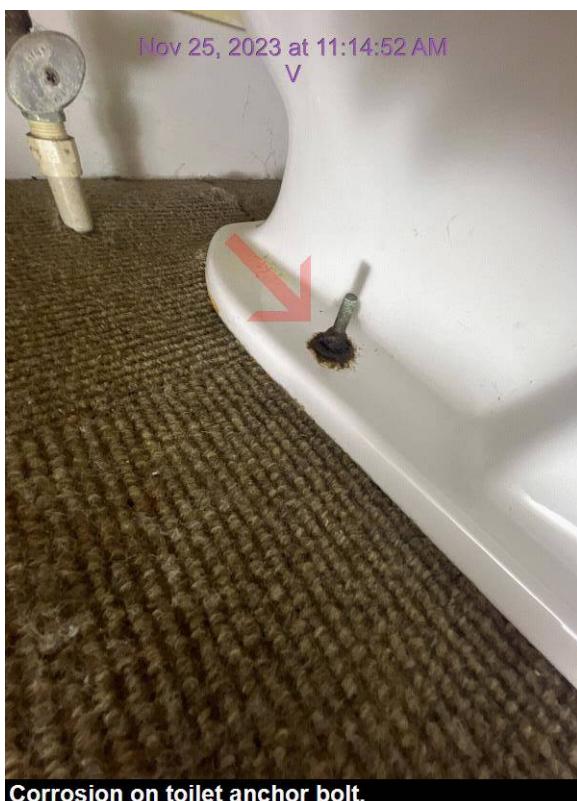
Condition: Fixtures & Surround: POOR. The cold water faucet handle, on the sink, is seized. Have a licensed plumber repair or replace the sink faucet to restore operation. The anchor bolts, that secure the toilet to the flange, are corroded. Have a licensed plumber replace the wax seal, flange and anchor bolts to reduce the potential for leaks to develop.

Corrosion on toilet anchor bolt.

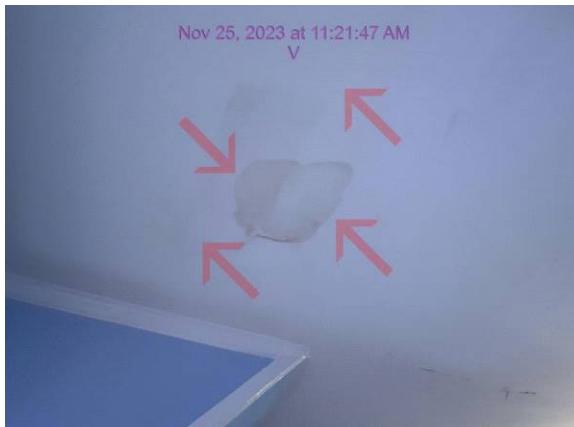
Staining/moisture damage under bathroom.

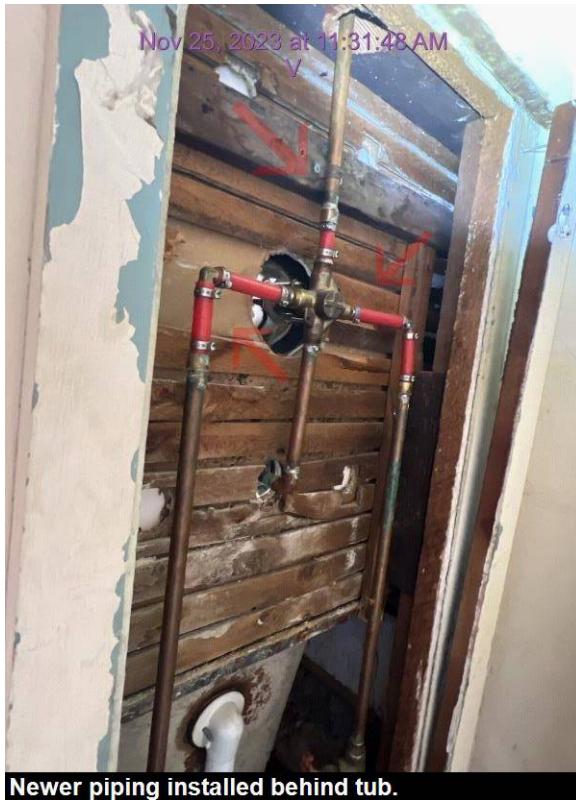
Newer piping installed behind tub.

*Plumbing leaks: (ALL ACTIVE) Active leakage was observed on the ceiling below this bathroom. See comments
LEAKS SHOULD BE REPAIRED above.
PRIOR TO CLOSING)*

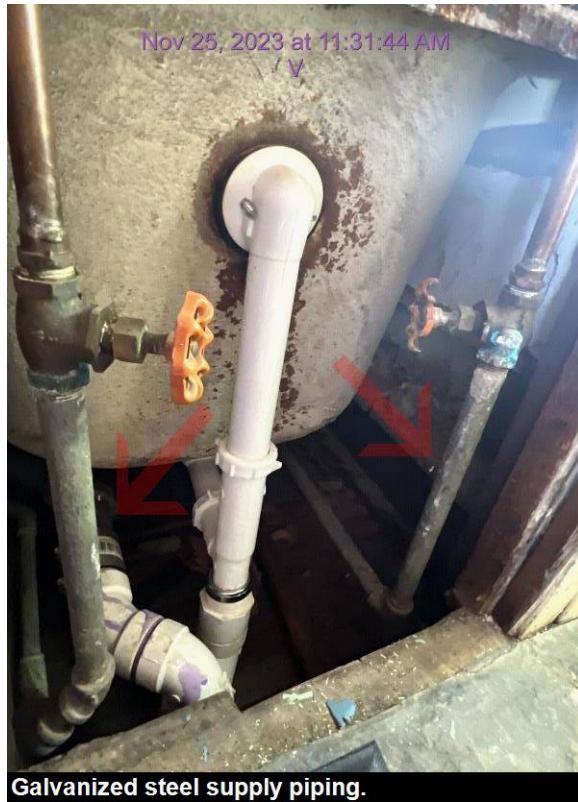
Galvanized steel supply piping.

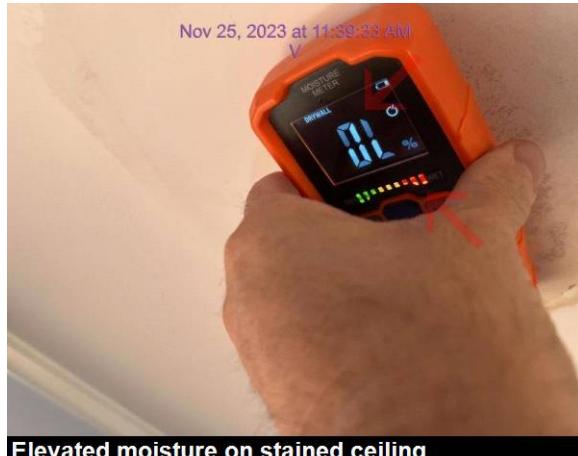
Elevated moisture on stained ceiling.

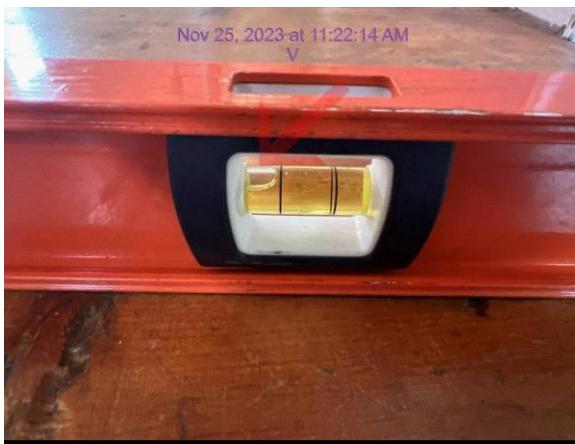
INTERIOR FLOORS: Although some level of settlement/deflection to the floors should be expected due to the age of this home, excessive deflection was noted in multiple areas on the first and second floors. The floor, in the left two bedrooms, have settled over an inch and half. A similar amount of deflection was noted to the first story ceiling below these bedrooms. Deflection and settlement noted to the floors in multiple other areas of the home. Powder post beetle damage noted to multiple joists within the basement. Have the structure of this home further evaluated by a licensed structural engineer to determine best means of reinforcement and repairs PRIOR to closing. All necessary repairs and reinforcement should be completed by a qualified structural contractor as per the engineer's findings/recommendations to prevent further movement.

Extensive deflection to wood floor.

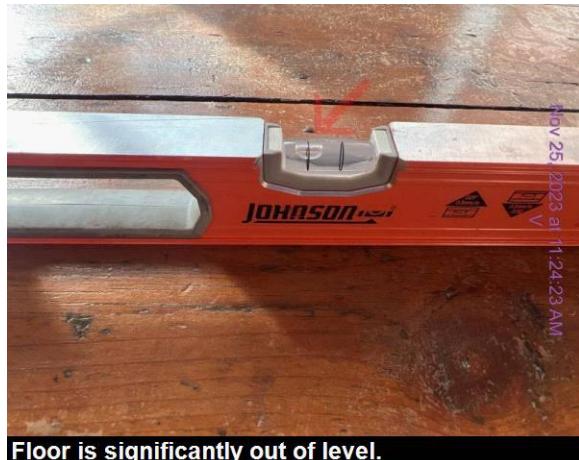
Floor is significantly out of level.

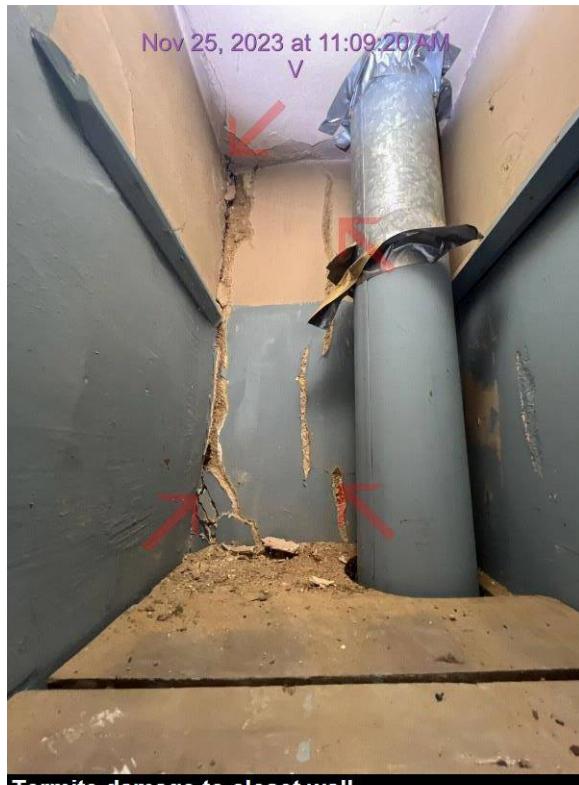
INTERIOR WALLS: Termite damage noted to the wall within the closet (to the left of the left fireplace). Cracks extend upward into the wall in the front left bedroom above this area. There is the strong potential for termite damage to exist to the framing within this wall cavity. Have a qualified structural contractor open up the walls to determine extent of suspected damage present PRIOR to closing. Any damaged framing should be replaced by a qualified structural contractor. See the report by the wood destroying insect inspector for need for termite treatment. See the report by the wood destroying insect inspector for further information and need for treatment.

Termite damage to closet wall.

replaced by a qualified structural contractor. See the report by the wood destroying insect inspector for need for termite treatment.

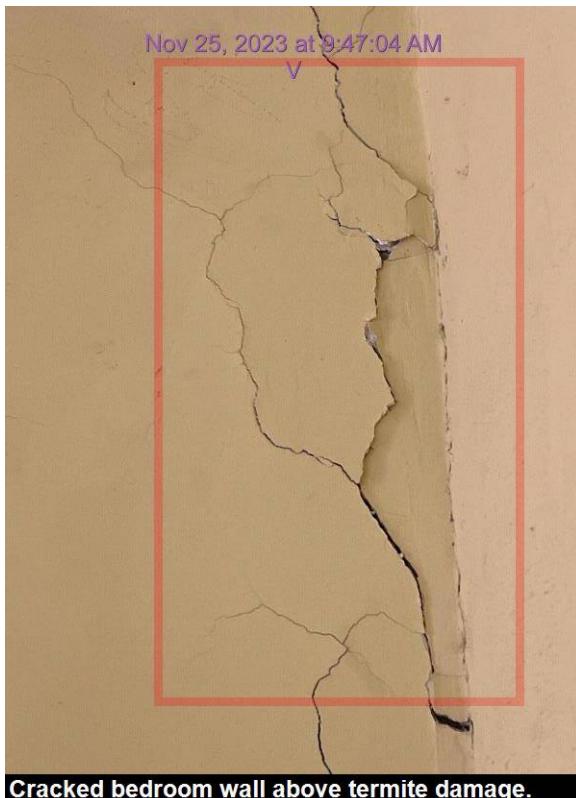
Cracked bedroom wall above termite damage.

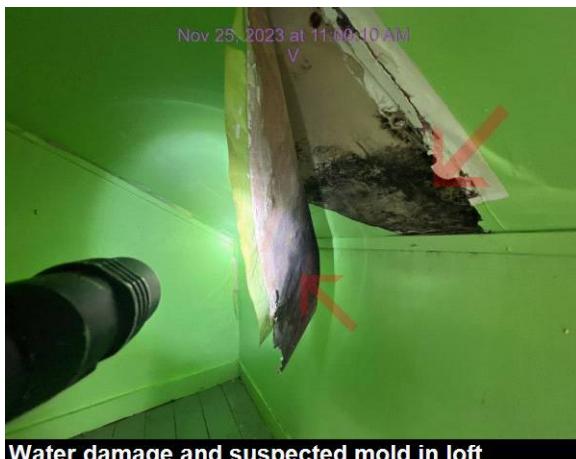
INTERIOR CEILINGS: Moisture damage noted to the drywall in the loft above the kitchen. The dark discoloration, on drywall, likely contains mold growth of some type. There is the potential for damage to exist to the framing above the drywall. Staining extends to the laundry room ceiling below this loft. Have a qualified contractor remove the damaged drywall and reinforce or replace any damaged framing and sheathing PRIOR to closing. The inspector does NOT perform mold testing. Consult a qualified environmental contractor for further evaluation PRIOR to closing. Any necessary remediation should be professionally completed PRIOR to closing. Staining, on the rear wall and ceiling in the closet in the right rear bedroom, contained a higher level of moisture when compared to the adjacent non-stained areas. Staining was also observed on the ceiling in the left rear bedroom. Have a qualified contractor make all necessary repairs PRIOR to closing. Cracking and some staining noted on the header that runs across the front of the second story bedroom. This area appears to have been recently repainted. See the Roof section of the report in regard to deficiencies.

Water damage and suspected mold in loft.

The inspector does NOT perform mold testing. Consult a qualified environmental contractor for further evaluation PRIOR to closing. Any necessary remediation should be professionally completed PRIOR to closing. Staining, on the rear wall and ceiling in the closet in the right rear bedroom, contained a higher level of moisture when compared to the adjacent non-stained areas. Staining was also observed on the ceiling in the left rear bedroom. Have a qualified contractor make all necessary repairs PRIOR to closing. Cracking and some staining noted on the header that runs across the front of the second story bedroom. This area appears to have been recent repainted. See the Roof section of the report in regard to deficiencies.

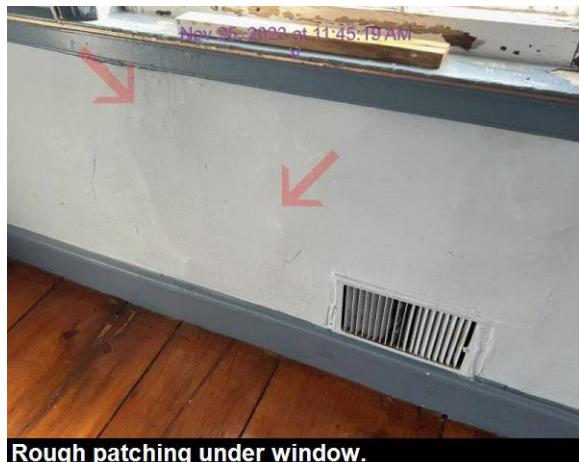
Rough patching under window.

POOR. The lower areas of the large fixed sash windows in the rear wall of the left addition, have been repainted (interior and exterior of these windows). Staining is visible through the paint. Staining was observed on the wall below the right side window in the right rear bedroom. Moisture damage noted to the front wall adjacent to the window in the front wall above the staircase landing. Although both areas were currently dry, there is the potential for recurring leaks depending on weather conditions. Have further evaluated by a qualified contractor and all necessary repairs completed to prevent recurring leaks. See the Exterior section of the report for further window deficiencies.

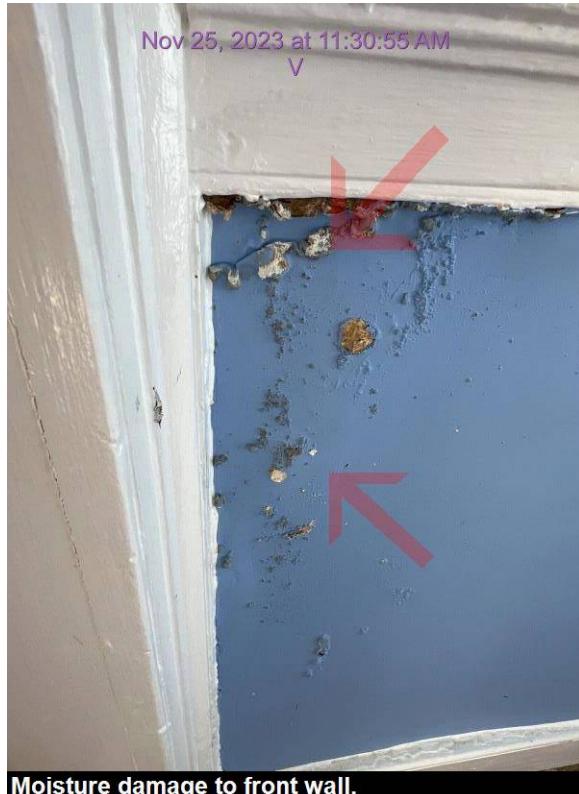
Moisture damage to front wall.

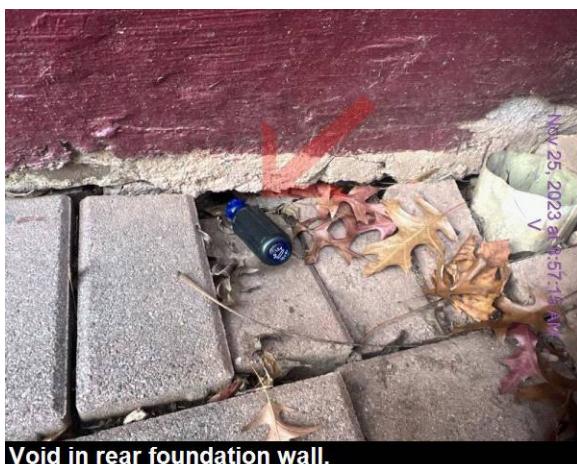
Void in rear foundation wall.

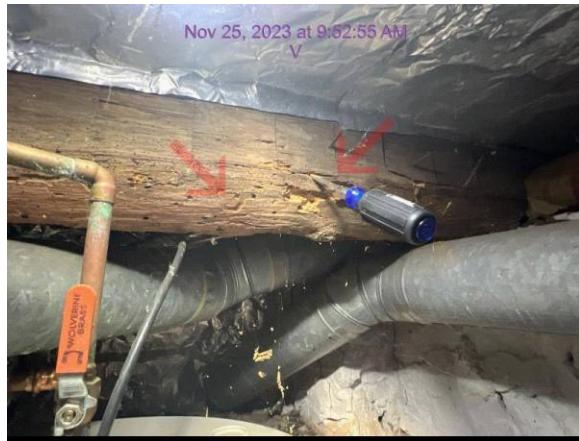
Powder post beetle damage to joist.

POOR. Powder post beetle damage noted to multiple joists and beams in the basement. The extent of damage can NOT be fully determined without removal of some of the insulation and vapor barrier (applied to the underside of the wood plank flooring). The main beam is being supported with old hand hewn wood posts without adequate footings. A few screw jack columns have been installed in a few locations within the basement. Wood to soil contact was observed in the visible area of the crawlspace (under the right side of this old home). There is the potential for further rot and wood destroying insect damage to exist to the framing in this inaccessible crawlspace. The floors, on both stories of this home, are very unlevel. Have a licensed structural engineer further evaluate the framing, throughout this home, PRIOR to closing. All damaged framing should be replaced or reinforced by a qualified structural contractor as per the engineer's findings.

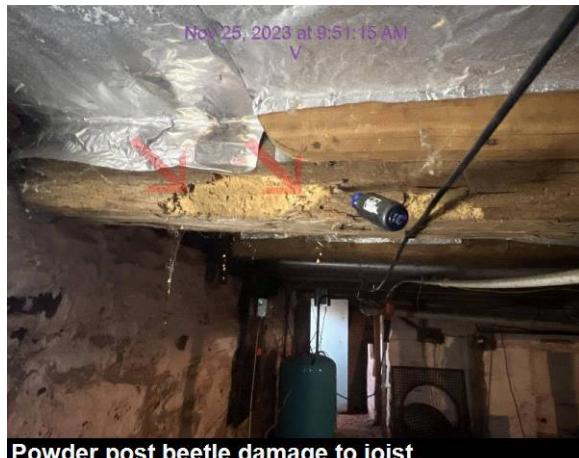
Powder post beetle damage to joist.

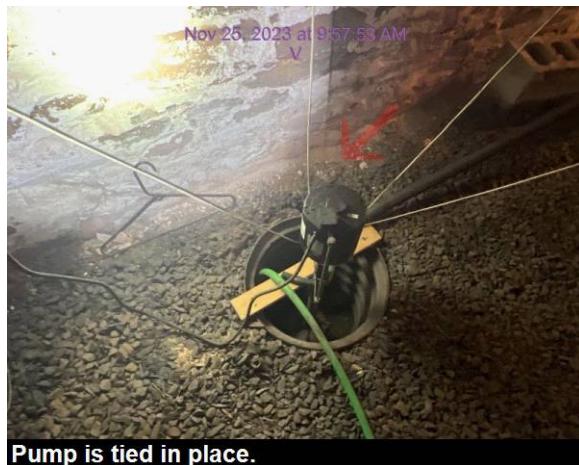
POOR. The pump is being held up with multiple pieces of rope. Power to the pump is being supplied by means of extension cord wiring. The pump and discharge piping has been installed in an unprofessional manner. Have a licensed plumber install a submersible pump and rigid discharge pipe to ensure proper operation when needed. A licensed electrician should install a dedicated circuit and receptacle to safely power the sump pump.

Pump is tied in place.

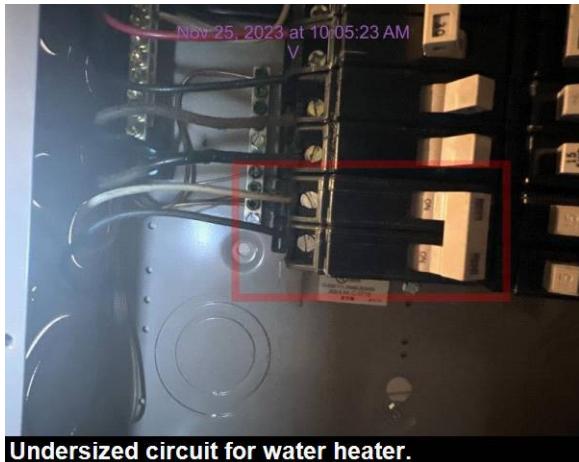
Undersized circuit for water heater.

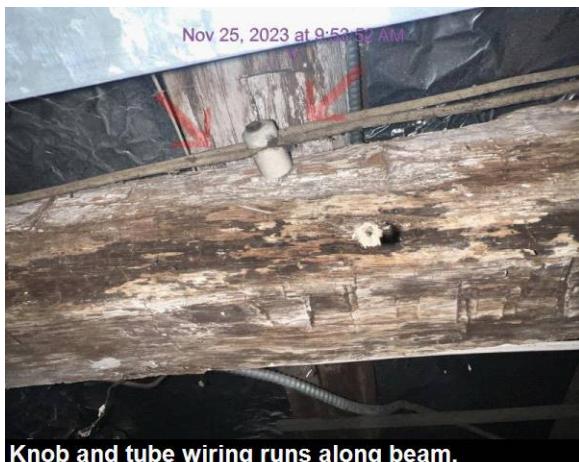
Knob and tube wiring runs along beam.

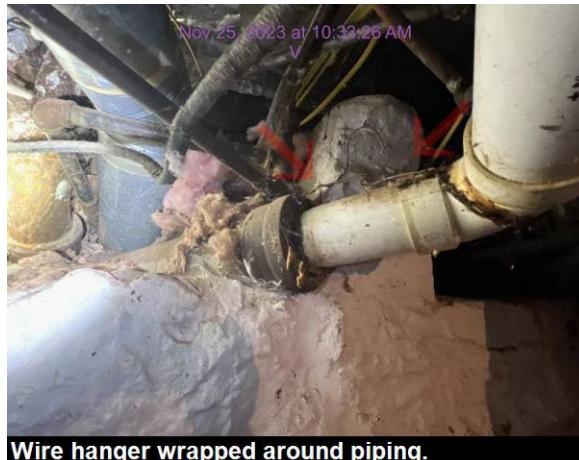
Wire hanger wrapped around piping.

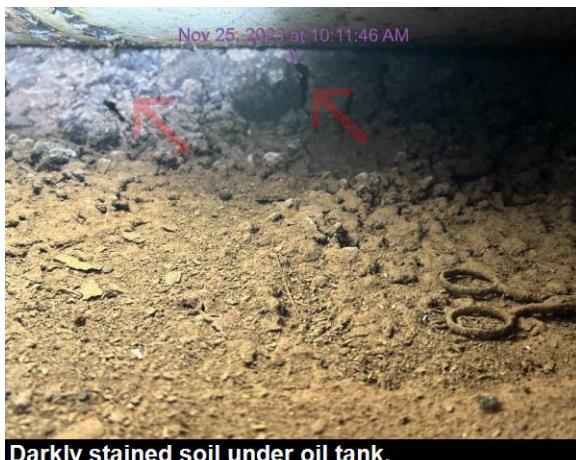
contractor PRIOR to closing. Any necessary remediation should be completed by a qualified environmental contractor as needed. This tank as well as the vent and fill pipes (which still extend to the exterior of the home) should be removed PRIOR to closing. The inspector makes NO deliberate attempt to locate potential underground fuel storage tanks that may have been in use prior to the tank located in the basement.. Due to the environmental concerns associated with underground fuel storage tanks, HIGHLY recommend having a qualified environmental contractor conduct an underground tank search PRIOR to closing. Any tank(s), that may be located, should be professionally removed with all necessary permits and permit approvals PRIOR to closing.

Darkly stained soil under oil tank.

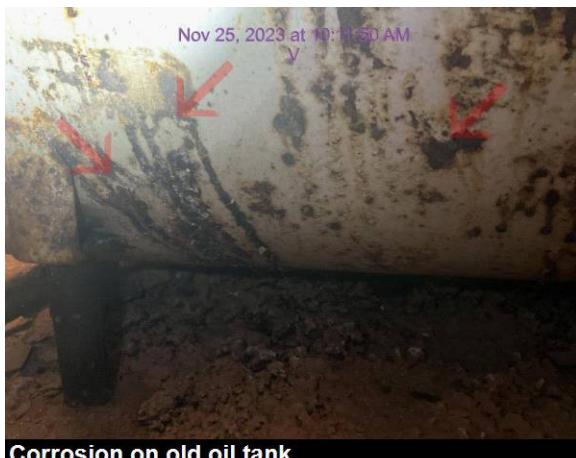
Corrosion on old oil tank.
