28 Anne Dr  
Freehold, NJ 07728

**Inspection reference: 060918JM1**

**Confidential Inspection Report**  
**28 Anne Dr**  
**Freehold NJ 07728**

**June 9, 2018**

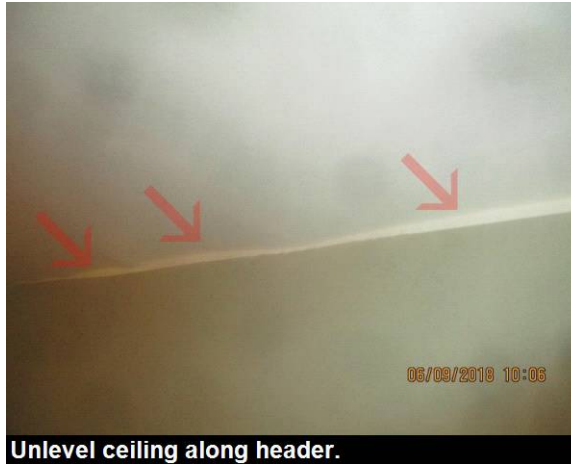
POOR. The dining room ceiling is unlevel (along the header between the dining and living rooms). The ceiling should be repaired PRIOR to repainting. Stains noted in the closet of the front left bedroom. Although the stains tested dry with a moisture meter, there is the potential for recurring leaks to occur. See the Attic and Roof sections of the report for additional information.

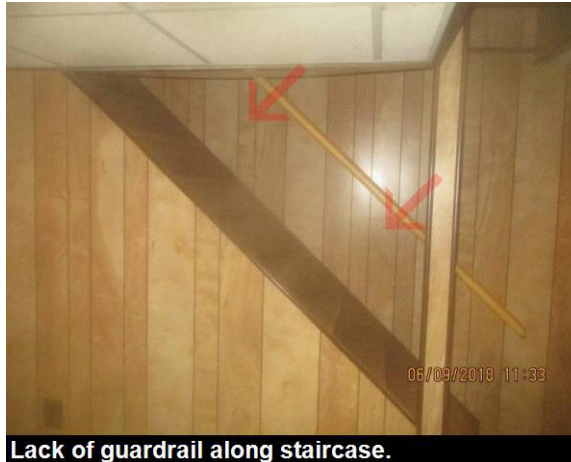
FAIR. The staircase lacks a guardrail. This presents the potential for injury. Have a qualified contractor install a guardrail to improve safety.
