12 Howell Lane
Somerset, NJ 08873

Inspection reference: 020724JM1

Confidential Inspection Report
12 Howell Lane
Somerset NJ 08873

February 7, 2024

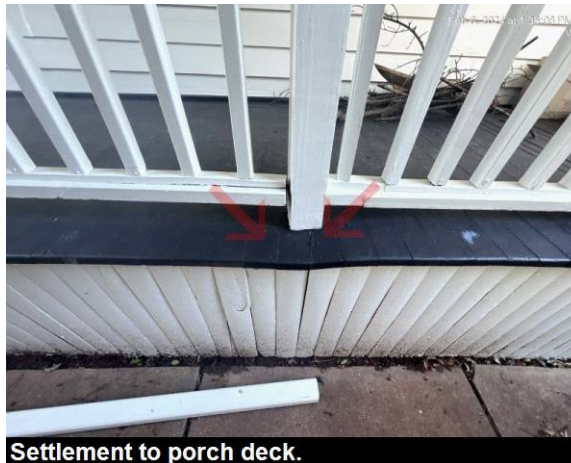
PORCHES AND STEPS TO BUILDING

PORCHES AND STEPS TO BUILDING: Significant settlement noted to the porch deck that extends along the right side of the home. The porch structure has also pulled away from the house. Trim has been installed over the gap between the porch decking and the walls of the home. The support posts penetrate the soil with NO visible evidence of footings (as visible from the basement windows). Some areas of the guardrail, around the perimeter of the porch, are loose. Wood plank cladding has been installed around the perimeter of the wraparound porch. The majority of the framing, under the porch, is

NOT visible for inspection. Potential for further damage/deterioration to exist that is NOT visible for inspection. This long wraparound porch requires major repairs and reinforcement at this time. Consult qualified contractors for estimates for major repairs/reinforcement or complete replacement PRIOR to closing. The steps, that lead up to the porch, have been constructed with open risers. Have a qualified contractor enclose the open risers to improve safety.

POOR. Significant settlement noted to the porch deck that extends along the right side of the home. The porch structure has also pulled away from the house. Trim has been installed over the gap between the porch decking and the walls of the home. The support posts penetrate the soil with NO visible evidence of footings (as visible from the basement windows). Some areas of the guardrail, around the perimeter of the porch, are loose. Wood plank cladding has been installed around the perimeter of the wraparound porch. The majority of the framing, under the porch, is NOT visible for inspection. Potential for further damage/deterioration to exist that is NOT visible for inspection. This long wraparound porch requires major repairs and reinforcement at this time. Consult qualified contractors for estimates for major repairs/reinforcement or complete replacement PRIOR to closing. The steps, that lead up to the porch, have been constructed with open risers. Have a qualified contractor enclose the open risers to improve safety.

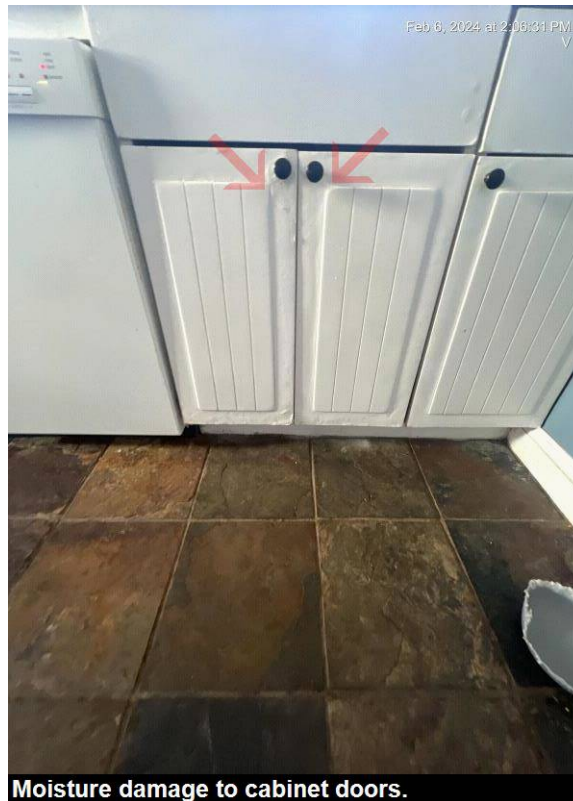
FAIR. Moisture damage noted to the doors under the kitchen sink. Loose hinges and hardware noted on multiple cabinet doors and drawers. Have a qualified contractor make all necessary repairs to restore proper operation of the doors and drawers.

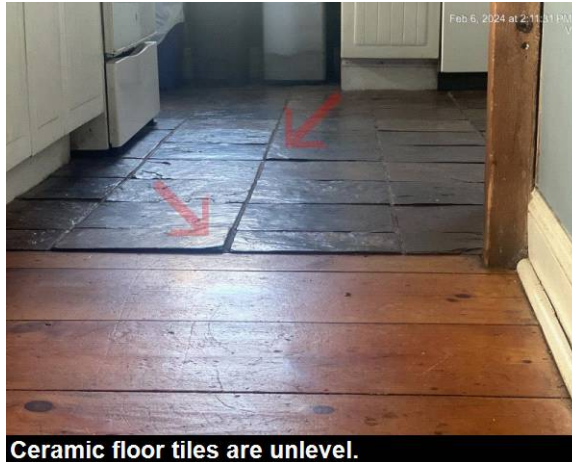
FAIR. The ceramic tiles have been installed unlevel. Some tiles protrude higher than others which can present a trip hazard. Worn and deteriorated grout noted between various tiles. The ceramic tiles have likely NOT been installed over a proper underlayment. Have a qualified flooring contractor replace the ceramic tile flooring as desired.

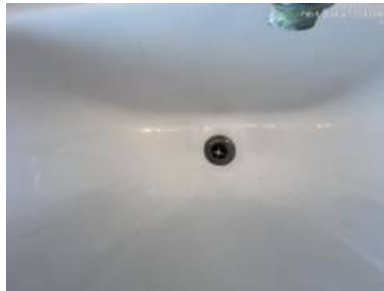
BATHROOM 1

HALF BATHROOM (FIRST STORY): The pedestal sink is loose at the connection to the wall. The cold water handle, on the sink faucet was NOT functional. The faucet handle is seized and would NOT turn. Have a licensed plumber make all necessary repairs to both improve safety and restore proper operation of the sink. The sink stopper is damaged and should be replaced. Note: This half bathroom has been built into a small closet. There is minimal clearance between the fixtures and the walls. It should be determined if a permit and all necessary permit approvals were obtained for construction of this half bathroom PRIOR to closing. This small half bathroom does NOT contain a source of ventilation. Have a licensed HVAC contractor install an exhaust fan that vents to the exterior.

Condition: Fixtures & Surround: POOR. The pedestal sink is loose at the connection to the wall. The cold water handle, on the sink faucet was NOT functional. The faucet handle is seized and would NOT turn. Have a licensed plumber make all necessary repairs to both improve safety and restore proper operation of the sink. The sink stopper is damaged and should be replaced. Note: This half bathroom has been built into a small closet. There is minimal clearance between the fixtures and the walls. It should be determined if a permit and all necessary permit approvals were obtained for construction of this half bathroom PRIOR to closing.

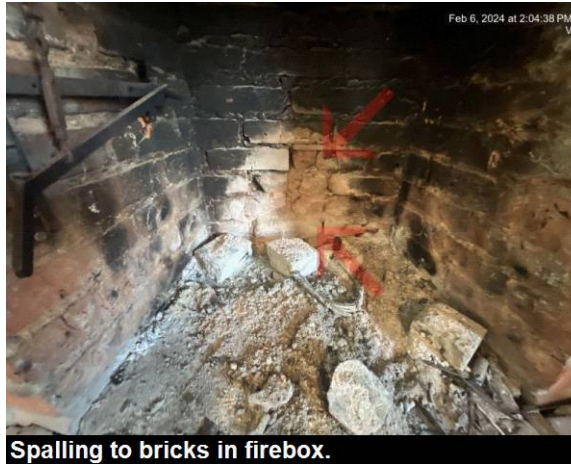
FIREPLACE AND CHIMNEY: Spalling noted to the bricks within the firebox. Although a liner has been installed in the old brick chimney, cracks and deterioration were observed to the fireplace and chimney structure. The cracks would suggest that some movement has occurred to the masonry fireplace and chimney. Wood timbers are in direct contact with the masonry fireplace structure (as visible from the basement). Spalled brick also noted in the attic portion of the chimney as well as just below the dining room floor (visible from the basement). This fireplace presents a FIRE SAFETY HAZARD and should NOT be used. Consult a qualified chimney contractor to determine if the fireplace and chimney can be repaired to restore operation. Due to the small firebox, the fireplace may have originally been intended for coal and not wood.

POOR. Spalling noted to the bricks within the firebox. Although a liner has been installed in the old brick chimney, cracks and deterioration were observed to the fireplace and chimney structure. The cracks would suggest that some movement has occurred to the masonry fireplace and chimney. Wood timbers are in direct contact with the masonry fireplace structure (as visible from the basement). Spalled brick also noted in the attic portion of the chimney as well as just below the dining room floor (visible from the basement). This fireplace presents a FIRE SAFETY HAZARD and should NOT be used. Consult a qualified chimney contractor to determine if the fireplace and chimney can be repaired to restore operation. Due to the small firebox, the fireplace may have originally been intended for coal and not wood.

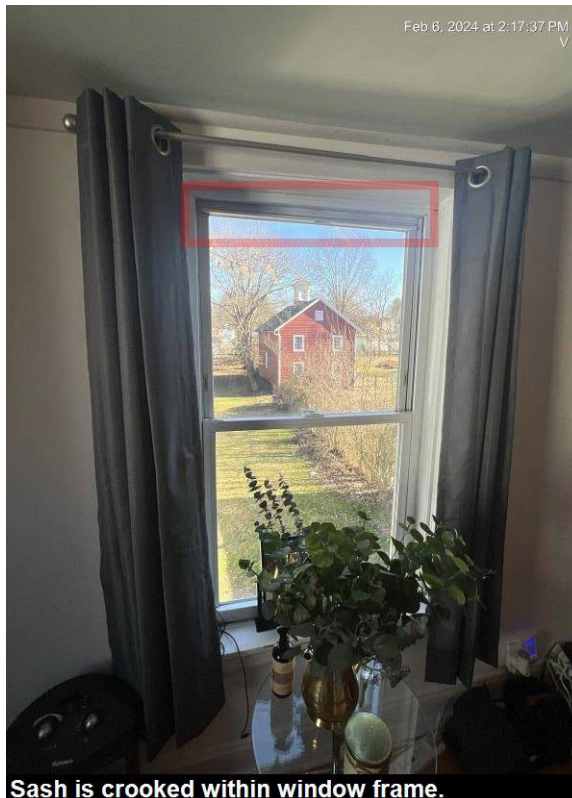
WINDOWS: The top sash, of various bedrooms windows, falls down when the windows are unlocked. This presents the potential for injury. The sashes, in the left window in the rear bedroom, are crooked and would NOT latch and lock. Have a qualified contractor repair or replace these windows to improve safety. Condensation noted between the glass panes of the living room windows. As the seal, between the insulated glass panes, is compromised, additional condensation will likely develop over time. Have the compromised sashes replaced by a qualified window contractor.

POOR. The top sash, of various bedrooms windows, falls down when the windows are unlocked. This presents the potential for injury. The sashes, in the left window in the rear bedroom, are crooked and would NOT latch and lock. Have a qualified contractor repair or replace these windows to improve safety. Condensation noted between the glass panes of the living room windows. As the seal, between the insulated glass panes, is compromised, additional condensation will likely develop over time. Have the

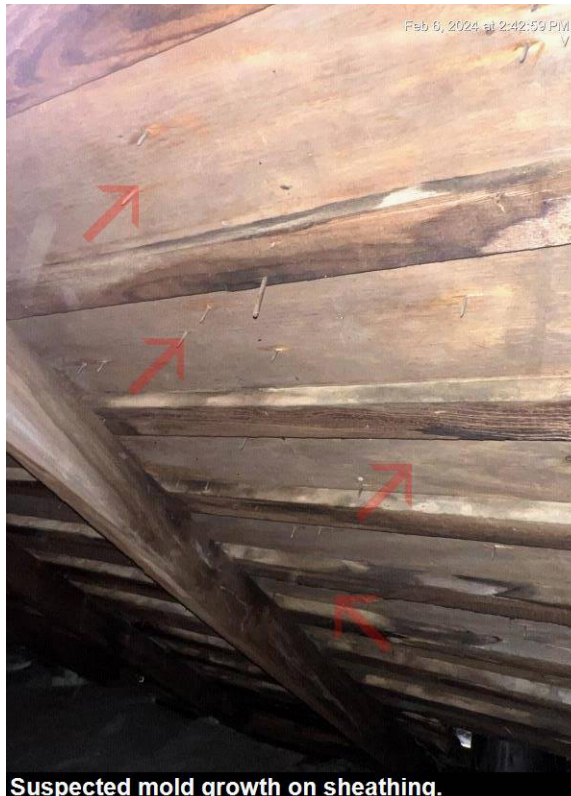
ATTIC MOISTURE OBSERVATIONS: Staining, around the chimney, was dry at this time. However, as light is visible between the chimney and the adjacent roof sheathing, there is the potential for recurring leaks depending on weather conditions. The chimney flashing should be replaced along with the roofing. Discoloration on various areas of the plywood sheathing likely contains mold growth of some type. The inspector does NOT perform mold testing. As mold growth can present a health safety concern, it is advised to have the attic further evaluated by a qualified environmental contractor PRIOR to closing. Any identified mold growth should be professionally remediated as needed.

Staining, around the chimney, was dry at this time. However, as light is visible between the chimney and the adjacent roof sheathing, there is the potential for recurring leaks depending on weather conditions. The chimney flashing should be replaced along with the roofing. Discoloration on various areas of the plywood sheathing likely contains mold growth of some type. The inspector does NOT perform mold testing. As mold growth can present a health safety concern, it is advised to have the attic further evaluated by a qualified environmental contractor PRIOR to closing. Any identified mold growth should be professionally remediated as needed.

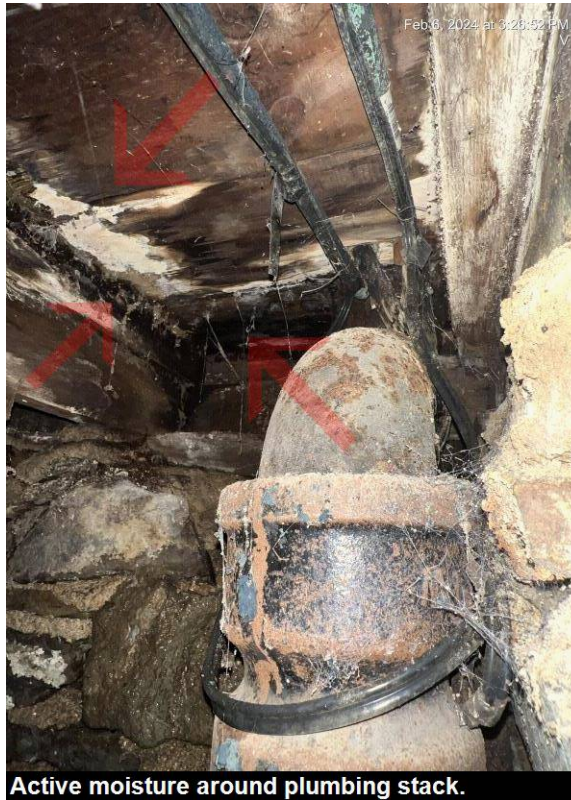
inspection. Further evaluation of the crawlspace should be completed PRIOR to closing. Rot was noted to the framing and sheathing - in the vicinity of the leaking plumbing vent stack. Have a qualified structural contractor replace the damaged framing and sheathing once the plumbing leaks are addressed. This crawlspace contains an exposed soil floor. Have a qualified waterproofing contractor encapsulate the floor and walls to reduce the potential for elevated moisture conditions that can be conducive to mold growth.

POOR. Rot was noted to the framing and sheathing - in the vicinity of the leaking plumbing vent stack. Have a qualified structural contractor replace the damaged framing and sheathing once the plumbing leaks are addressed. This crawlspace contains an exposed soil floor. Have a qualified waterproofing contractor encapsulate the floor and walls to reduce the potential for elevated moisture conditions that can be conducive to mold growth.

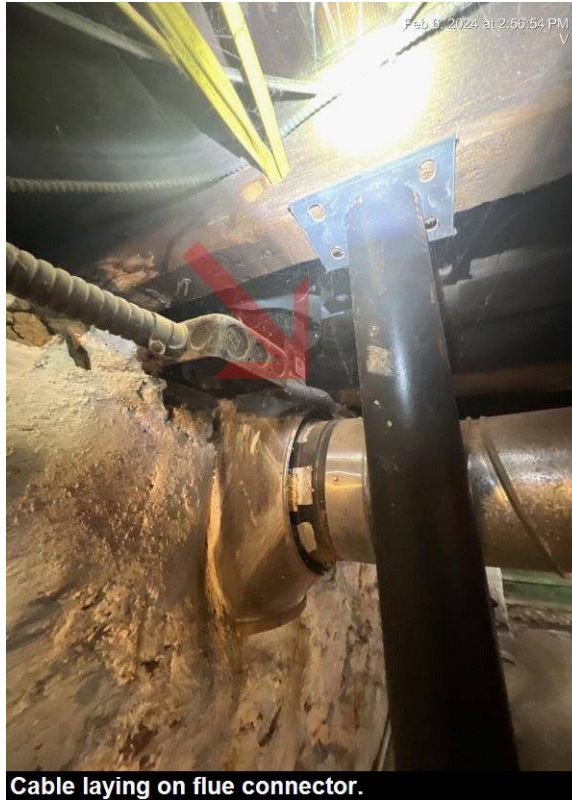
Cable laying on flue connector.
POOR. An old metallic "BX" type cable is laying on the boiler flue connector. This can result in overheating and damage to the wiring. Have a licensed electrician properly secure this wiring. Missing covers noted on multiple junction boxes in the basement and attic. This increases the risk for electrical shock. Covers should be installed on all open junction boxes to improve safety.
