1054 W. Chestnut St
Middletown, NJ 07748

Inspection reference: 112523JM2

Confidential Inspection Report

January 10, 2026

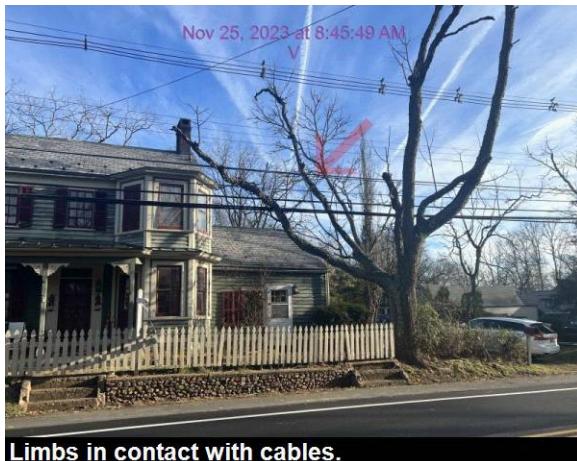
POOR. The limbs, of the large old tree at the front of the lot, are in contact with the utility lines that run along the street. Have a qualified tree contractor remove these limbs to reduce the potential for damage to the utility lines. Recommend removal of all vines from on and around the structure to help reduce the potential for damage to the siding. Due to the season, the condition of most of the trees could NOT be determined.

Monitor the property for dead trees and branches and have removed by a qualified tree contractor as needed. Keep trees and shrubs trimmed away from the building. Monitor condition of trees and prune as needed.

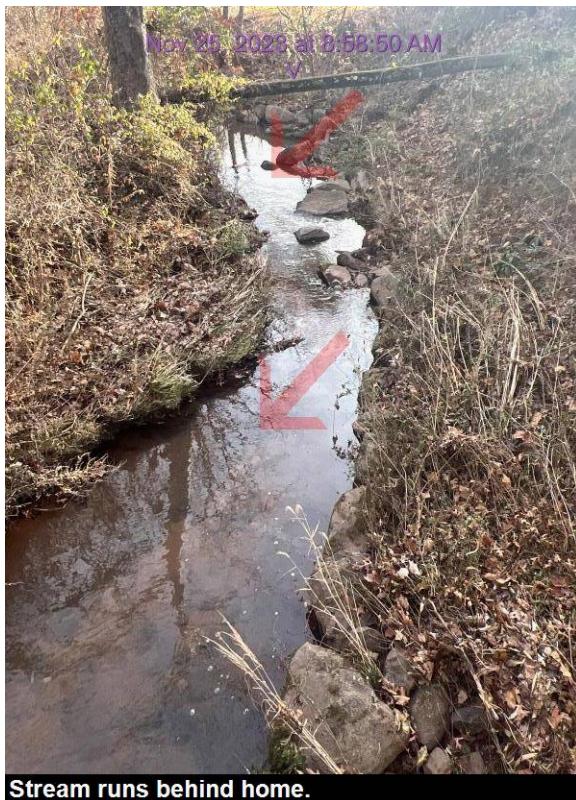
This home is located on a multi-acre lot. Woods are located behind the stream. A few downed trees were observed in the woods. The scope of this inspection is limited to the house and the grounds directly adjacent to the house only. A stream runs across the lot behind the house. The inspector makes NO determination as to the potential for the stream to overflow its banks during periods of heavy and/or extended rainfall. Obtain history of any possible prior flooding, due to this stream, from the owner PRIOR to closing.

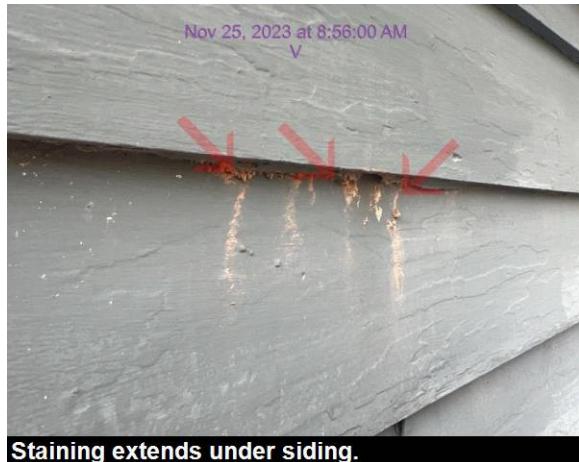
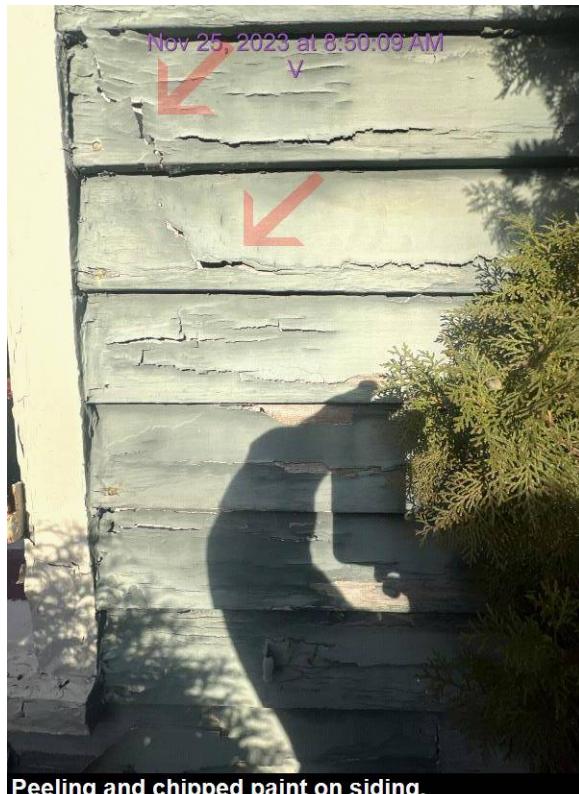
EXTERIOR WALL SURFACES

POOR. Loose clapboard siding was observed in multiple areas around the perimeter of the home. The siding is likely original to the home. Chipped and peeling paint noted on various areas of the siding. Due to the age of this home (233+ years old), there is the strong potential for lead paint to exist. Cracks noted in various clapboards. The siding has been installed over the studs without sheathing (in most areas). Although consistent with the age of this home, the lack of sheathing can result in moisture intrusion and drafts into the wall cavities. Brownish staining, under some of the clapboards on the rear of the home, can be indicative of moisture and wood destroying insect damage to the framing within the wall cavity. Have a qualified structural

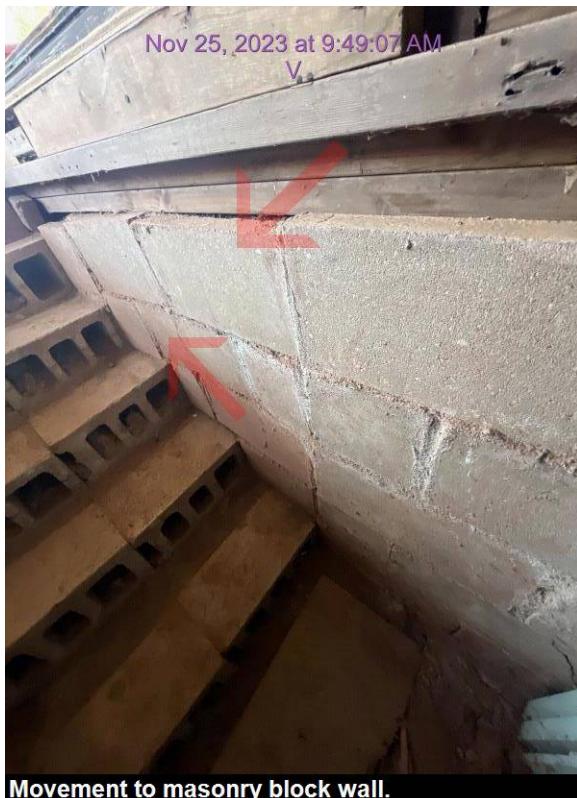
BASEMENT WALKOUT

BASEMENT WALKOUT: The masonry block walkout foundation has been poorly constructed. Movement noted to the masonry block walls. The masonry blocks, that comprise the steps, have been installed in the wrong orientation (the blocks have been laid on their side). The posts, that support the door framing, rest in the soil. This walkout has been constructed in a very unprofessional manner. Have a qualified mason contractor replace the walkout foundation and steps to improve safety.

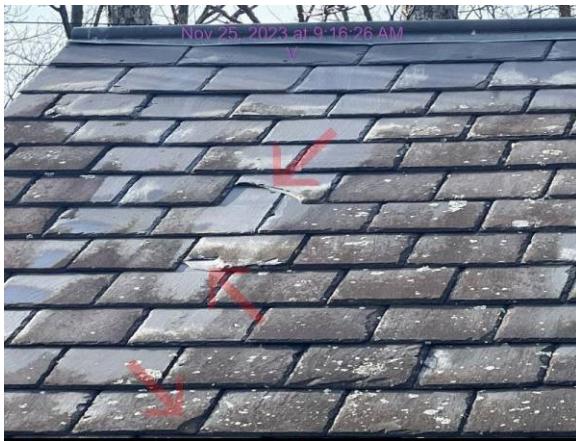
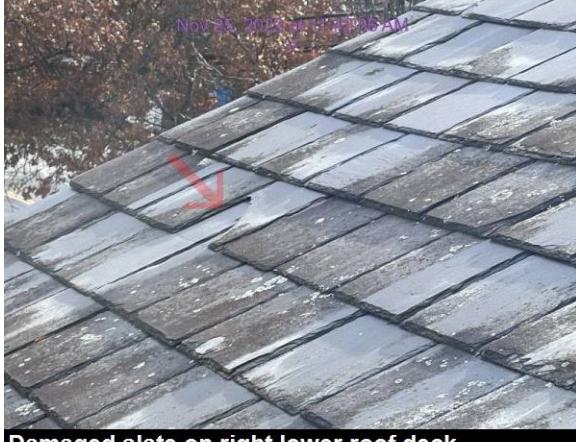
POOR. Damaged slates were observed in multiple areas of the upper roof surfaces as well as the lower right roof surfaces. Multiple stains and water damage were observed in the loft above the kitchen. Stains were also observed in the second story bedrooms. Extensive tar patching noted on the slates around both chimneys. Tar should NOT be considered a proper and permanent repair. Intermittent active leaks are probable during certain weather conditions (such as wind driven rain, heavy rain and snow accumulation). Have a qualified slate roof contractor replace all damaged slates and make all necessary repairs around both chimneys - to prevent recurring leaks in these

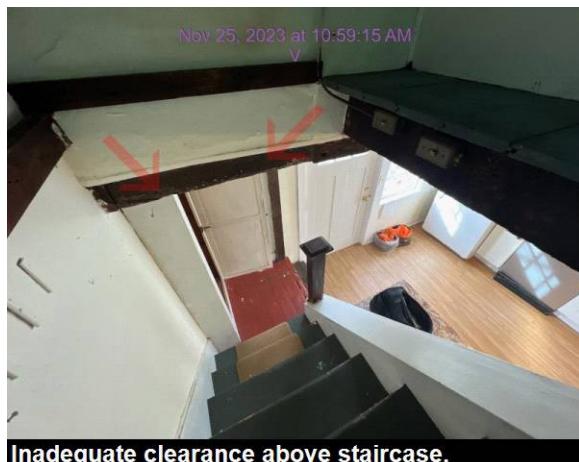
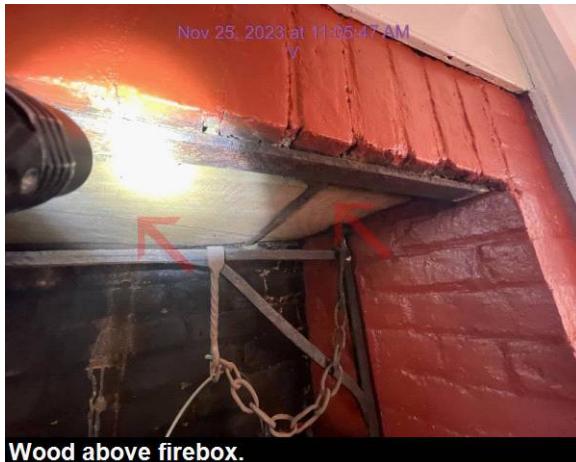
FIREPLACES

This home contains two masonry fireplaces which are NO longer operational.

POOR. Neither fireplace is operational. Wood planks have been installed above the firebox of each fireplace. The chimney flues are NO longer accessible for inspection/evaluation. The fireplaces are for decorative purposes only. Do NOT attempt to start a fire in either fireplace. Consult a qualified chimney/fireplace contractor to determine the costs involved in making one or both fireplaces operational PRIOR to closing.

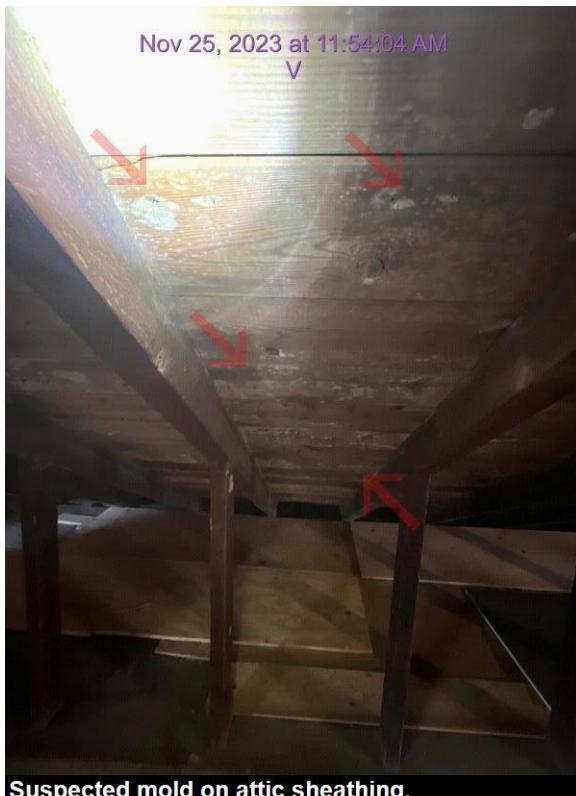
Staining, around both chimneys, was dry at this time. However, tar patching should be considered a temporary repair only. See the Roofing section of the report for additional information. Light spotty staining, on the sheathing, may contain mold growth of some type. The inspector does NOT perform mold testing. As mold growth can present a health safety concern, it is advised to have the attic further evaluated by a qualified environmental contractor PRIOR to closing. Any identified mold growth should be professionally remediated as needed.

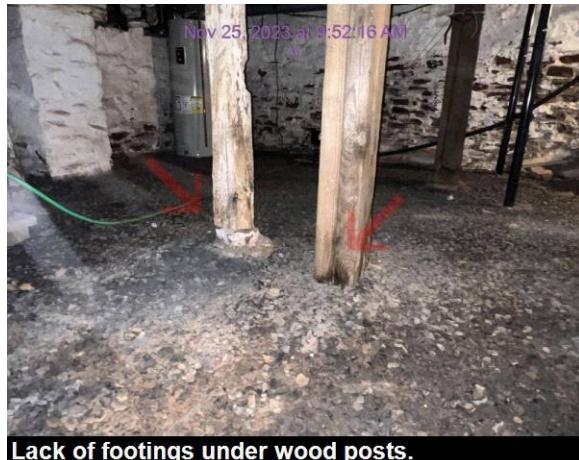
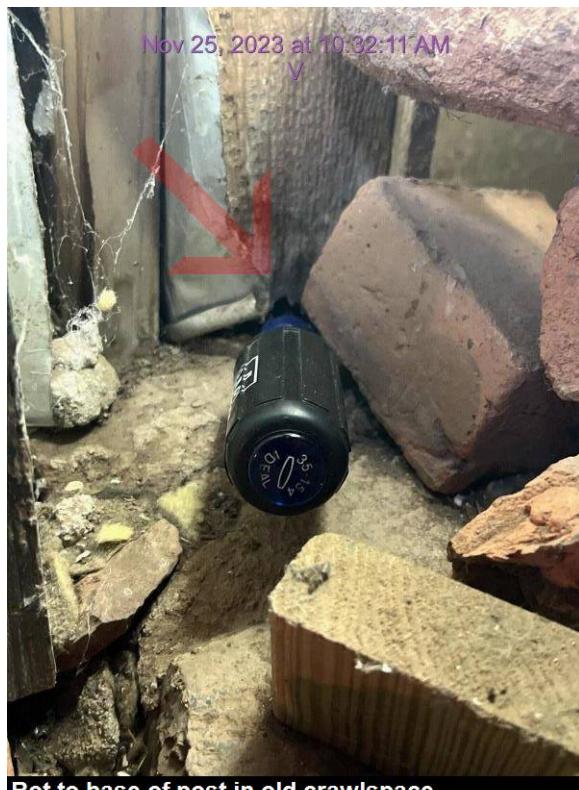
BASEMENT FLOOR

Concrete poured directly over the soil with NO provision for drainage or steel reinforcement. Consistent with the age of the of the home. Crushed stone.

FAIR. The crushed stone can allow for radon gas and moisture entry into the home. It is advised to have a qualified mason contractor install a concrete slab in this area.
